LIMITED INSPECTION FOR ASBESTOS CONTAINING MATERIALS AND LEAD IN PAINT

***JOHN PETTIBONE ELEMENTARY SCHOOL
NEW MILFORD, CONNECTICUT***

***TRC Project Number:
270902.0001***

Issued- February 10, 2017

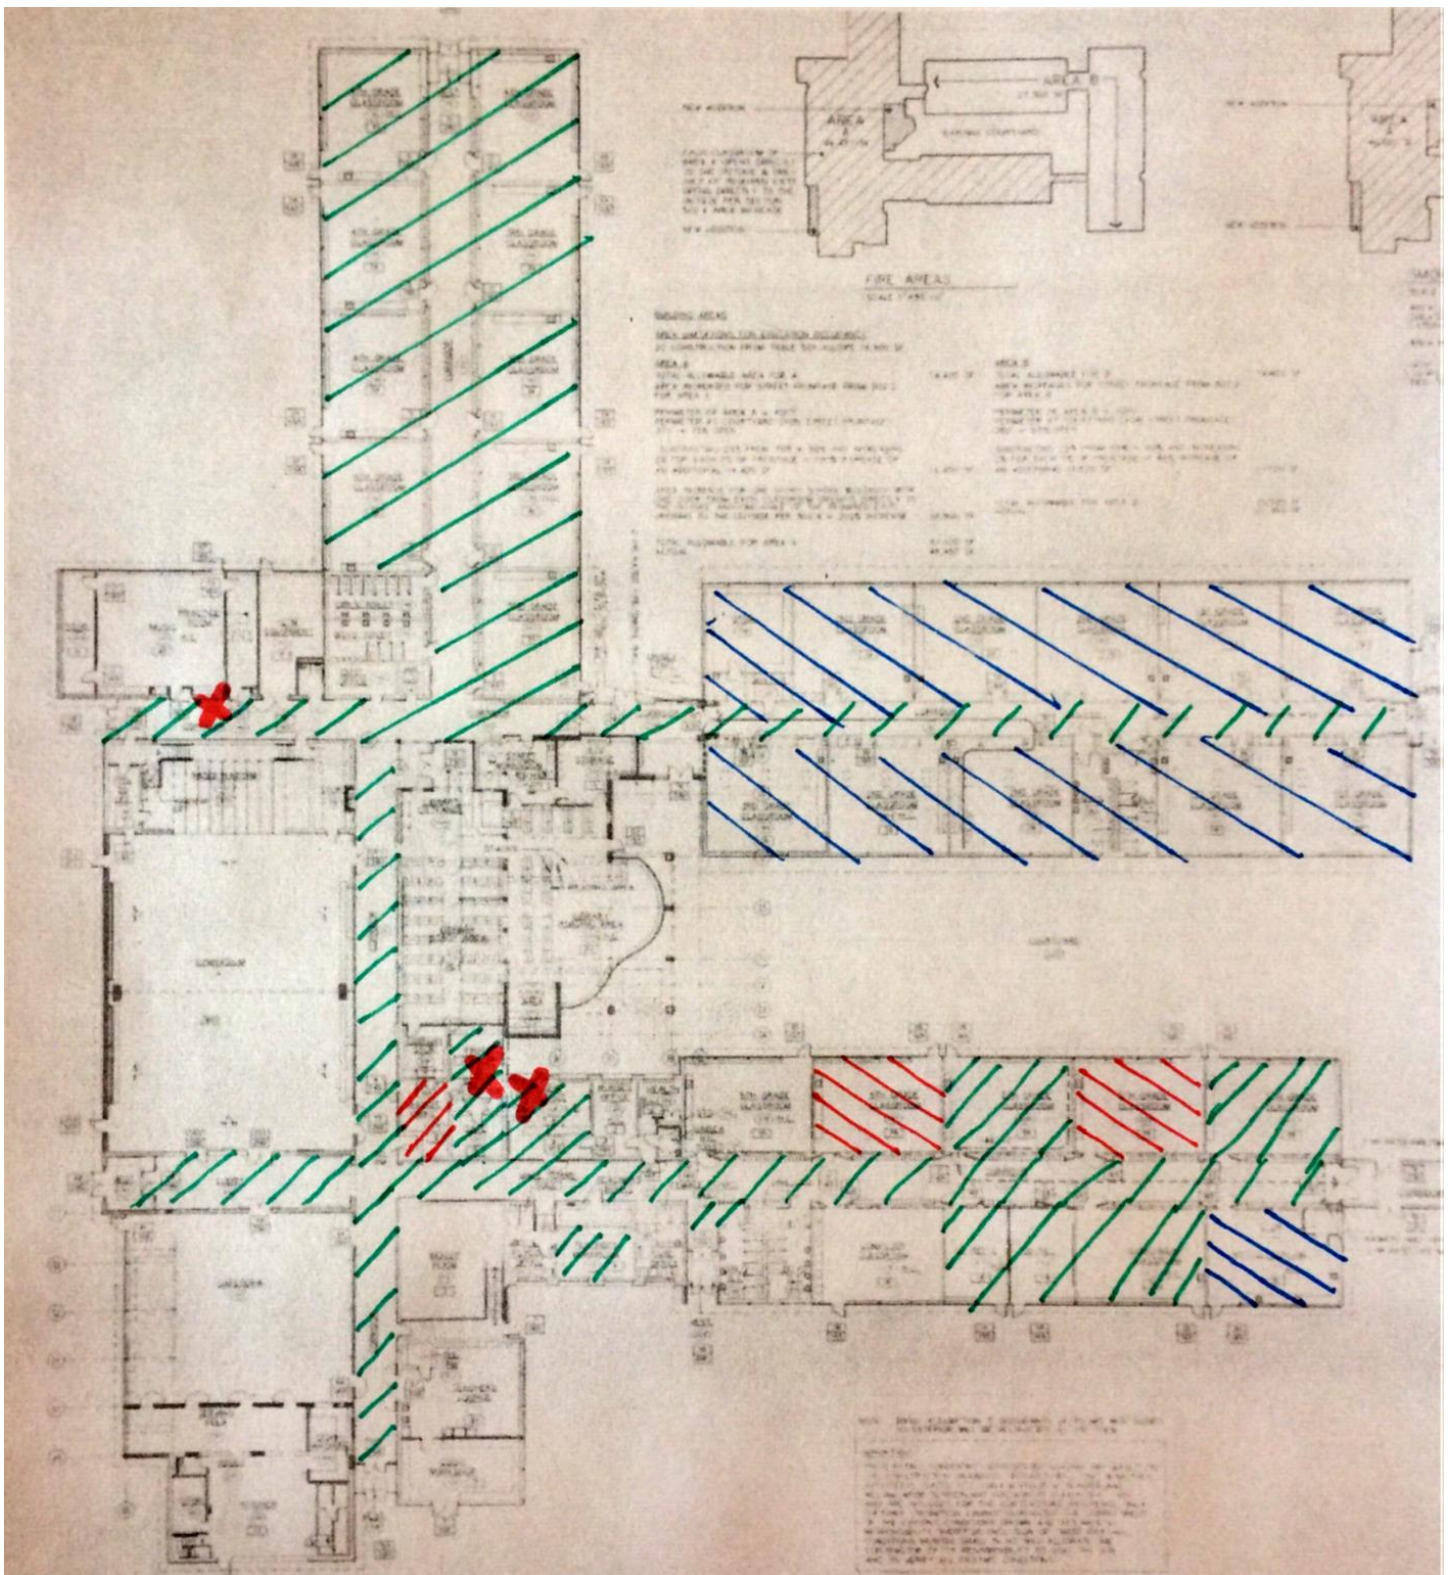
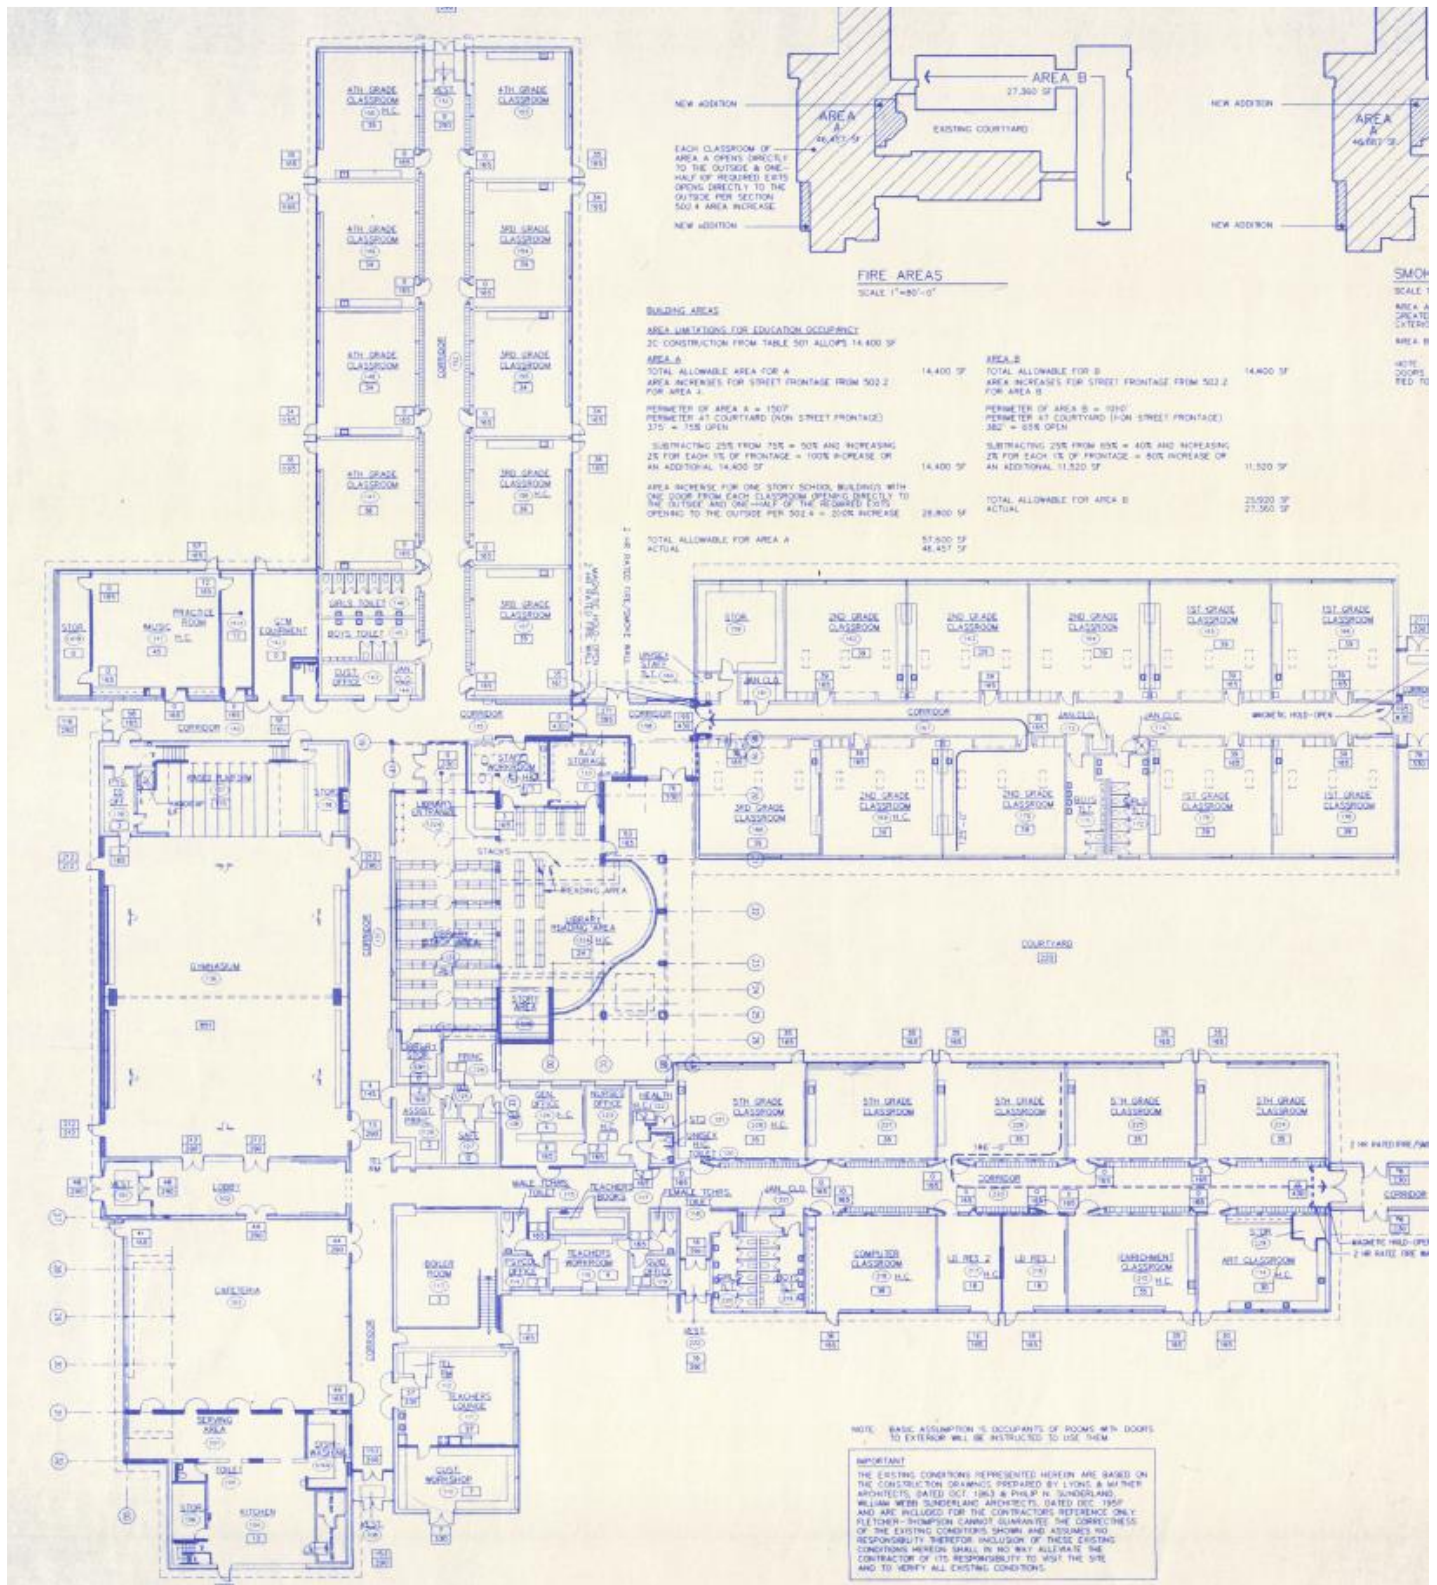
-   -> FT2- Green 9x9 Floor Tile and Black Mastic
-   -> FT8- Beige 9x9 Floor Tile
-   -> FT9- Dark Grey 9x9 Floor Tile
-   -> FT10- Red 9x9 Floor Tile and Black Mastic
- XX** -> MF/TSI/RFD- Miscellaneous Insulations
