Catherine Lillis Administrative Building

Building Conditions Assessment

50 East Street
New Milford, Connecticut 06776

Draft Report, October 6, 2023
Final Report, October XX, 2023

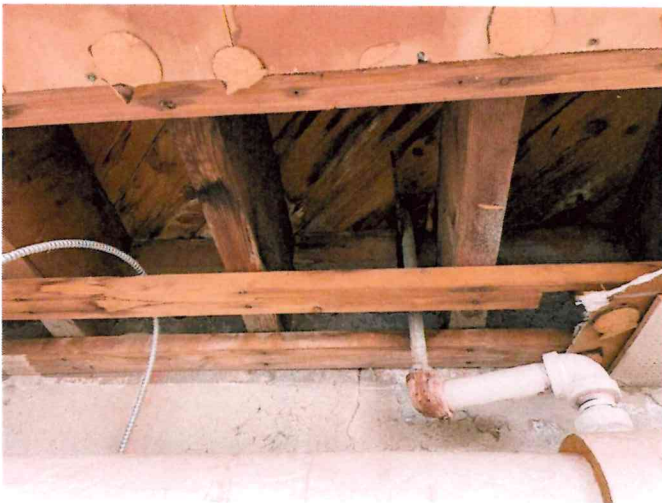
Typical floor joist construction bearing on perimeter masonry

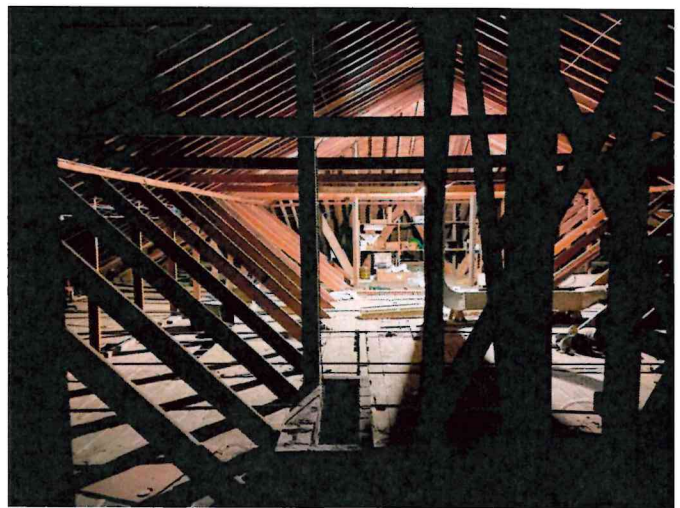
Attic roof construction – wood rafters & wood decking

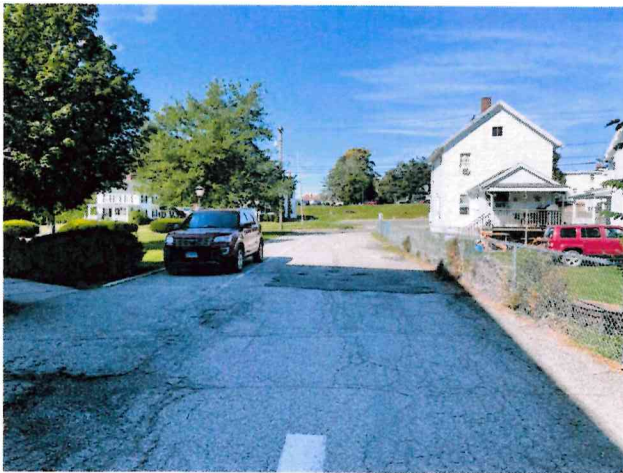
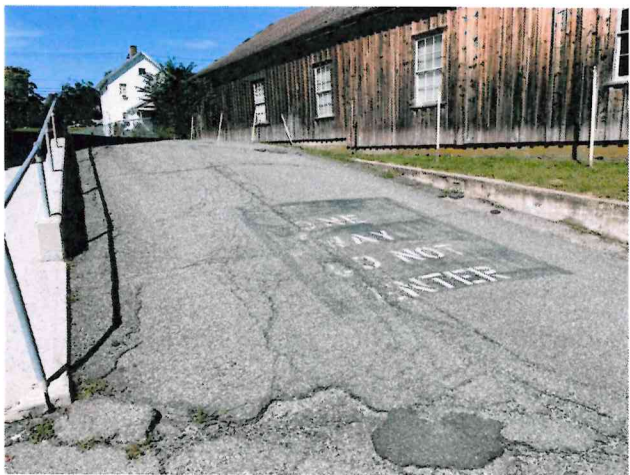
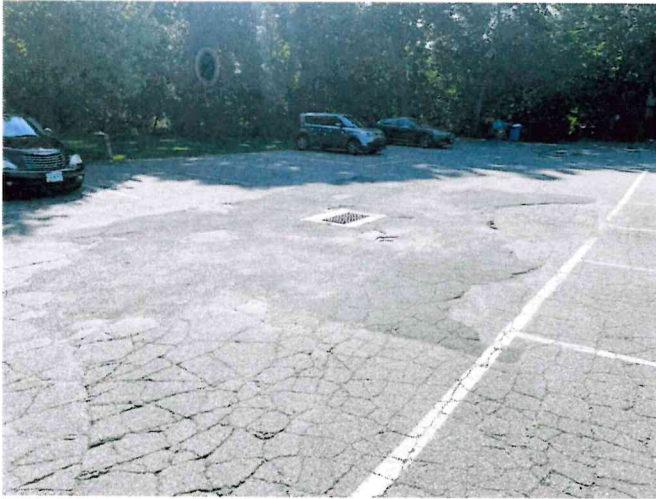
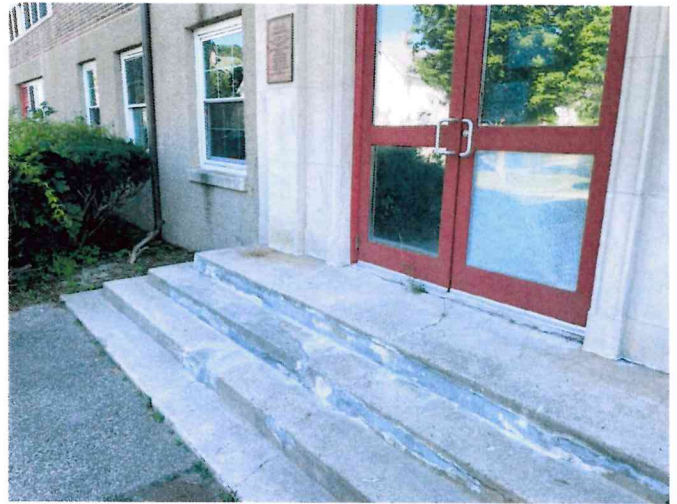
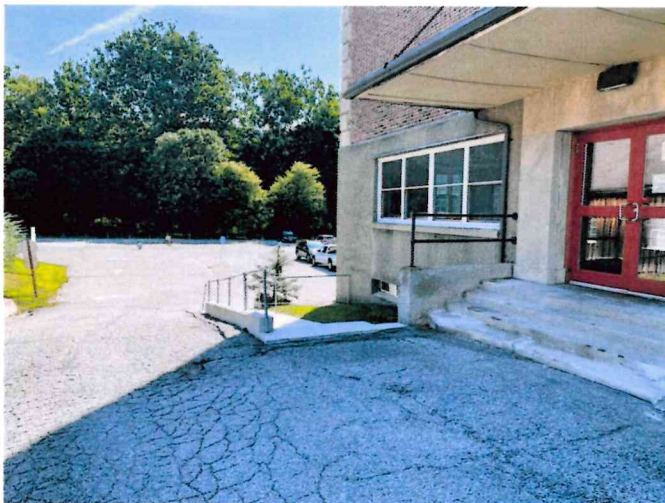
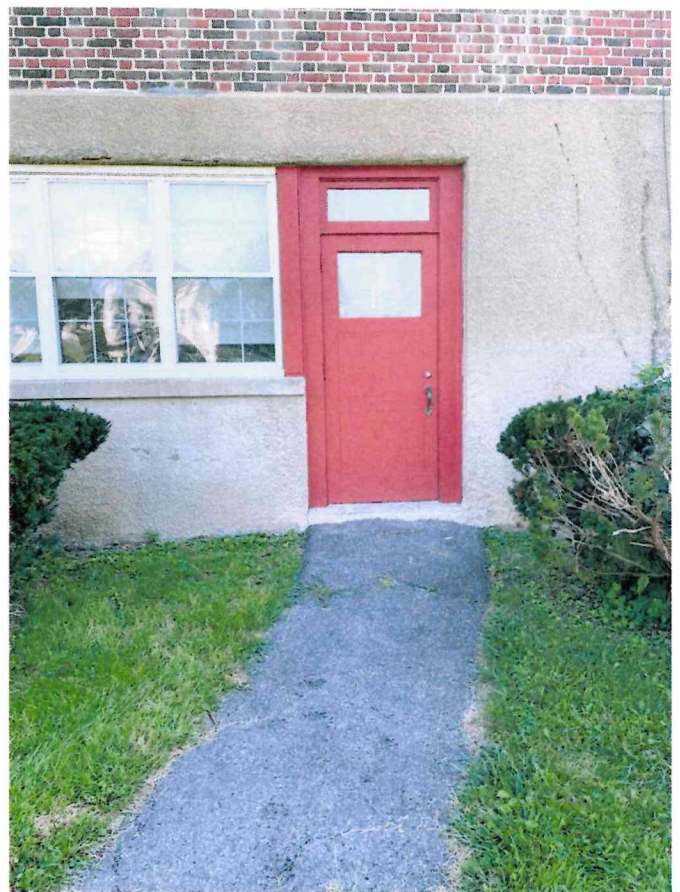
The Property located at 50 East Street is bound by East Street on West side, a restaurant (Oriental House) on the South Side, residences on the North side and woodlands on East side. The building structure is placed approximately in the middle of the parcel with a level grass lawn in the front (west side) along with a few mature trees. There are Bituminous concrete sidewalks connecting East Street with the building with secondary sidewalks that connect to the two ends of the building (north & south) along with smaller sidewalks connecting to various doors of the building. These bituminous sidewalks are all in poor condition. At the front door of the facility, there is a concrete stair with 4 risers that is in poor condition. There is also no code required handrails on this stair. On the South side of the building, there is also a 4-riser concrete stair that is equally in poor condition, with spalling concrete and exposed rebar. This stair also has no code compliant handrails. Concrete stairs with 3 risers also exist on the South-East side of the facility that are in poor condition without code complaint handrails. On the North side of the facility is also a 4-riser stair that is also in poor condition without code complaint handrails. On the North-East corner of the building, there is a concrete ramp that connects the North entry to the rear parking lot. This ramp has had recent work and is in fair condition. However, the handrail on this stair is not code compliant nor is the slope of the ramp code complaint. None of the primary entrance doors of the facility are ADA complaint due to the stair/risers at each location.

There is a bituminous concrete driveway on the North side of the property that connects East Street to the rear parking lot on the East side of the lot. This rear lot has striped parking for approximately 50 parking spaces. There is also a helicopter pad on the North-East side of the rear parking lot that serves the New Milford hospital, which is near the facility. The bituminous concrete on both this side driveway and rear lot are in poor condition.

- Replace all exterior Bituminous concrete sidewalks.
- Replace all exterior Bituminous concrete parking lots & driveway.
- Replace all exterior concrete stairs at N, S & W entrances.
- Install code complaint handrails at all stairs/ramps.
- Install code complaint concrete ramp/handrails on N/E side of building.

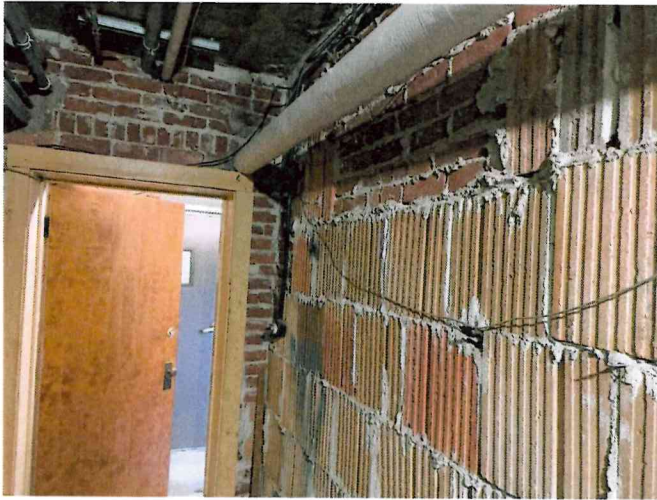
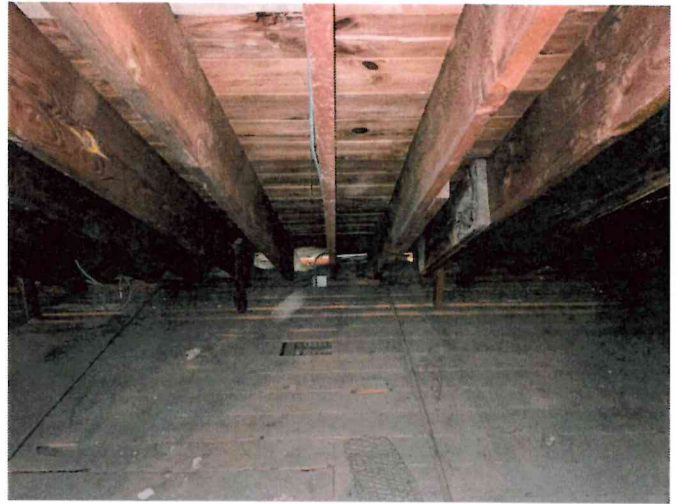
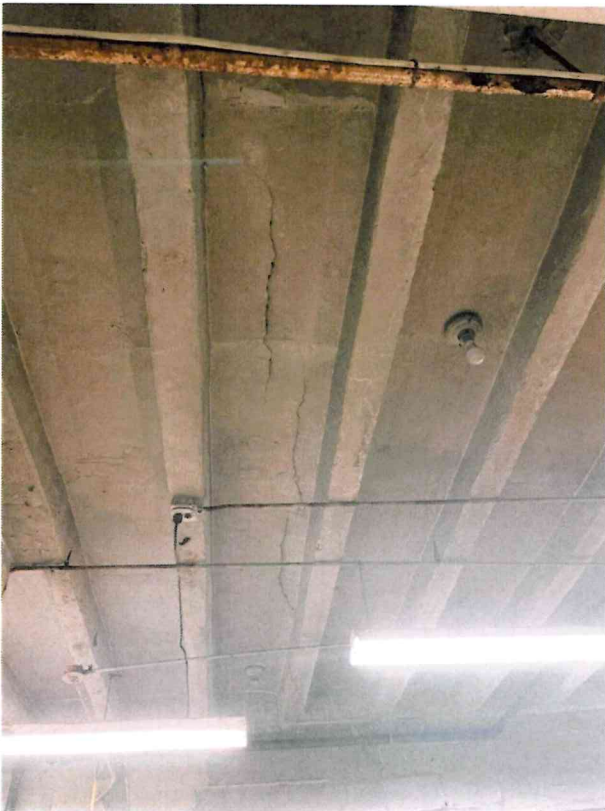
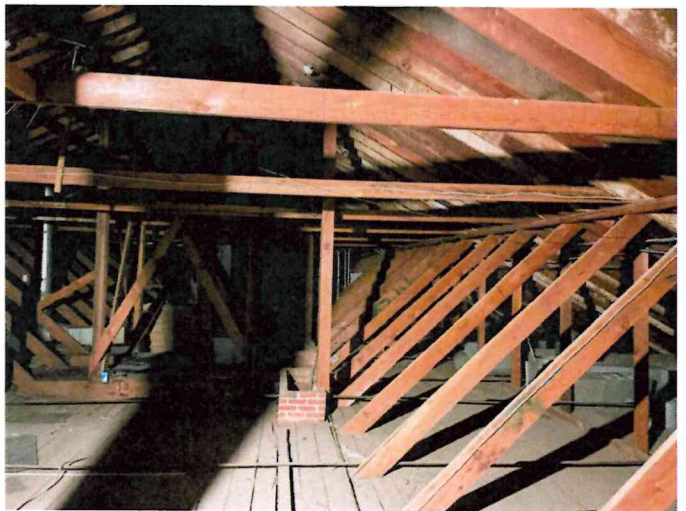
There were no signs of any significant structural deficiencies in any of the observed steel columns, terracotta load bearing interior or exterior walls, wood floor framing or wood roof framing. However, the floor over the boiler room is constructed with a one-way waffle slab. Between one of the T's showed a significant crack that would need further investigation. All other structural components appeared to be in good condition.

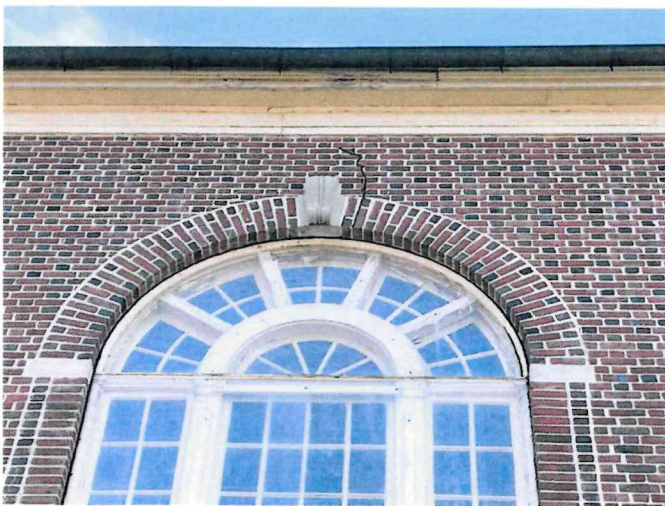
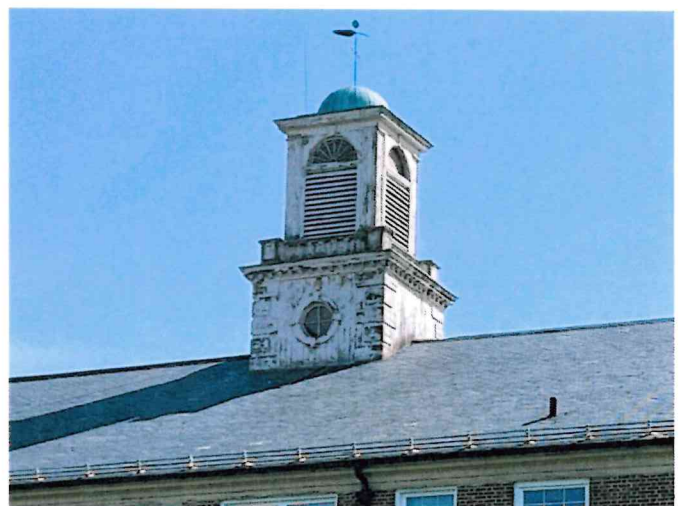
The Catherine Lillis Administrative building is a 3 story Masonry building with Concrete stucco veneer on the first floor and brick veneer on the second & third floor. There are also limestone surrounds on the North, South and West entrances along with limestone quoins on the 4 corners of the building. Above the north and south entrances are large Palladian windows spanning between the second & third floor. These large windows are trimmed in white painted wood. At the roof line is a white painted wood fascia & soffit. There are also copper gutters and downspouts around the entire perimeter of the facility. The roof consists of slate shingles on a wood deck and there are snow guards on the 4 primary hip roof. Centered on the building is a large 1.5 story wood framed and wood trimmed cupola with wood windows facing all 4 directions along with a copper dome and weathervane.

Starting from the ground up, the first story veneer is predominately stucco and is in fair condition. This stucco is likely applied to the terracotta block backing that makes up the backing masonry of the facility. There were a few dozen significant cracks present in the stucco on all 4 faces of the building. The second and third floor exterior veneer is 4" brick in good condition. There are a few locations on each face of the building that show signs of settlement cracks. A small portion of the brick on all 4 faces will also need minor replacing/repointing. The limestone quoins, windowsill and entry surrounds are all in very good condition with minor repointing/repairs needed. The primary windows of the facility are vinyl double hung windows with insulated glass. These windows have many more serviceable years before replacement is needed. However, many of these windows were observed needing caulking/trim where they intersect with the existing masonry building. The North and south Palladian windows are in fair/poor condition and will need repair/components replaced and new painting. If these windows are not replaced, new glazing compound is strongly recommended. On the first floor, there are a variety of small wood windows and louvers that are in poor condition and will need to be replaced. The wood fascia/soffit (at the gutter line) is in poor condition with portions showing significant rotting and will need significant repair consisting of replacement/restoration. The copper gutters and downspouts are older and are in fair/poor condition. The slate roof shingles are in poor condition on the sloped roofs and will need to be replaced soon. The large 1.5 story wood framed & sheathed cupola is in very poor condition and will likely need significant restoration/rebuilding and/or replacement. This also includes the 6-wood window, trim, copper dome and weathervane. There are a few small slate roofs on the east side of the facility that will also need replacement along with the wood fascia, soffits & copper flashings. There is also a small asphalt shingle roof on the east side of the facility that is in fair condition. 2 small flat roofs on the east side are EPDM membrane roofed and should be replaced. There is a large chain supporting canopy over the North entry stair door that appears to be in good condition. All perimeter doors are either aluminum or wood and all are in fair condition. However, they are not period correct for the facility and replacement should be considered. All perimeter wood trim needs stripping, priming and painting.

- Repair all cracks in exterior stucco veneer (first story)
- Repair all cracks in exterior brick & stone veneer.
- Repoint/replace all failed brick & joinery.

- Caulk/trim & repair all exterior vinyl double hung windows.
- Repair/replace failed components on N & S Palladian windows.
- Reglaze and reset all glass on N&S Palladian windows.

- Replace all perimeter wood windows (small windows at first floor)
- Replace all perimeter wood louvers (small louvers at first floor)
- Repair/replace perimeter wood fascia & soffit to match existing in kind.

- Replace the existing slate roof with a new slate roof.
- Replace all existing copper roof flashing, gutters & downspouts.
- Rebuilt/repair & restore existing wood cupola including louvers & 6 windows to match in kind.

- Replace existing copper dome roof (over cupola) and weathervane.
- Replace the small East side roofs with new slate roofs.
- Replace East side EPDM roof in kind.

- Strip, Prime and paint all exterior wood trim, fascia, soffits, cupola, etc.
- Replace all exterior doors with ADA complaint hardware & in keeping with historic standards.

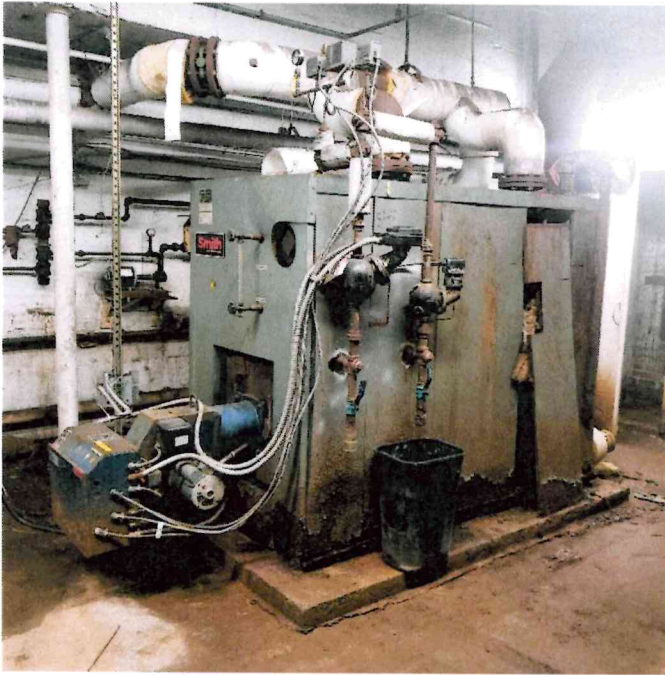
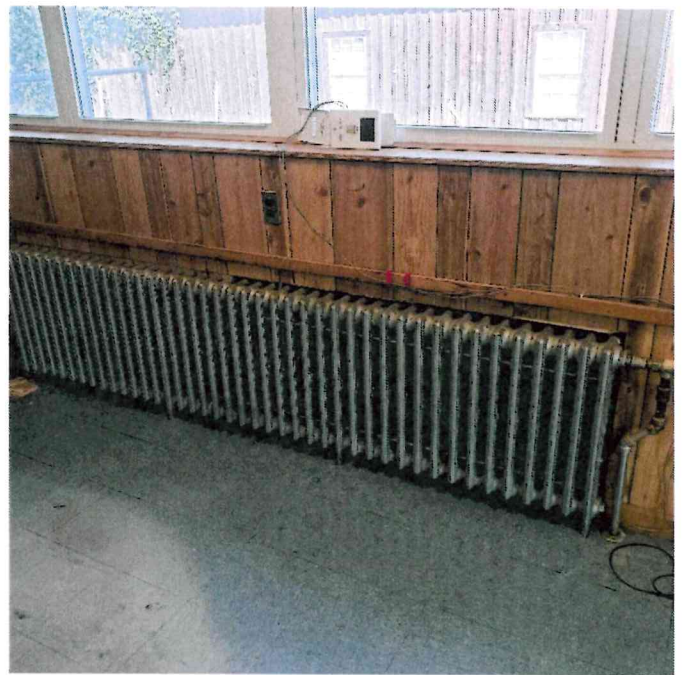
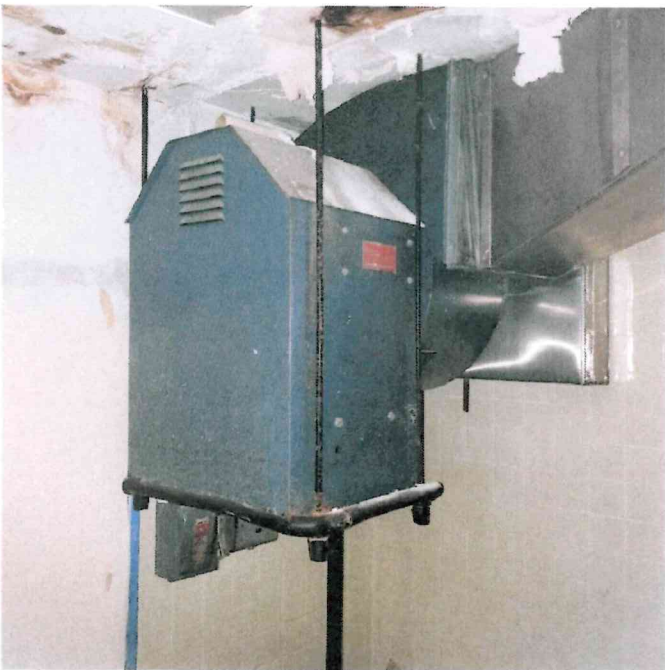
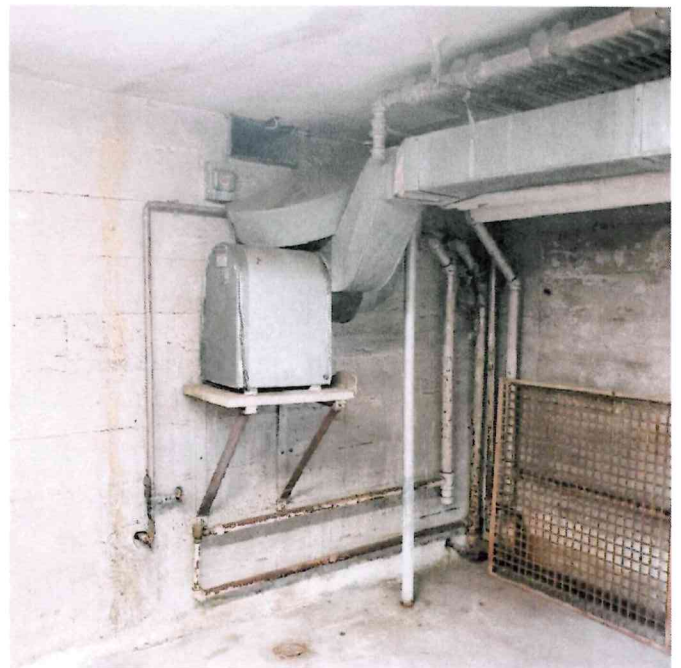
A central boiler plant located in the basement level mechanical room provides heating for the entire building. The existing steam boiler is an HB Smith Cast Iron sectional boiler with fuel oil Powerflame burners. The existing nameplate indicates the boiler is a 28A-10 series Smith boiler with a NET IBR Rating of 1,939,000 Btu/Hr. The boiler generates heat for the facility and distributes steam at 15 psi throughout the building. Steam is fed to equipment such as perimeter convection units, and baseboard radiation. With proper maintenance of the equipment, the life expectancy of the boiler is 30 years and the associated burner is approximately 20 years. Therefore, this equipment is beyond its life expectancy and in poor condition.

Flue gases are routed through breeching connected to a masonry chimney which terminates above the roof. The existing mechanical room does not contain provisions for combustion air for the boiler.

The piping distribution system throughout the building is original to the 1930 construction. Piping systems, with proper maintenance, can operate for 50 years. Therefore, the piping is beyond its serviceable life expectancy and should be replaced.

An existing underground fuel oil storage tank provides the fuel oil for the heating plant. Fuel oil piping is run under the rear parking lot from the tank into the building then routed through the basement level to the boiler. Oil appears to be recirculated between the tank and boiler via circulation pump. The fuel oil tank and associated underground fuel oil piping, Proteus tank monitoring system was replaced within the past 5 years.

systems. Existing exhaust systems appear to be damaged and in poor condition. The associated exhaust fans located in the attic are non-operable, well beyond their serviceable life and should be replaced.

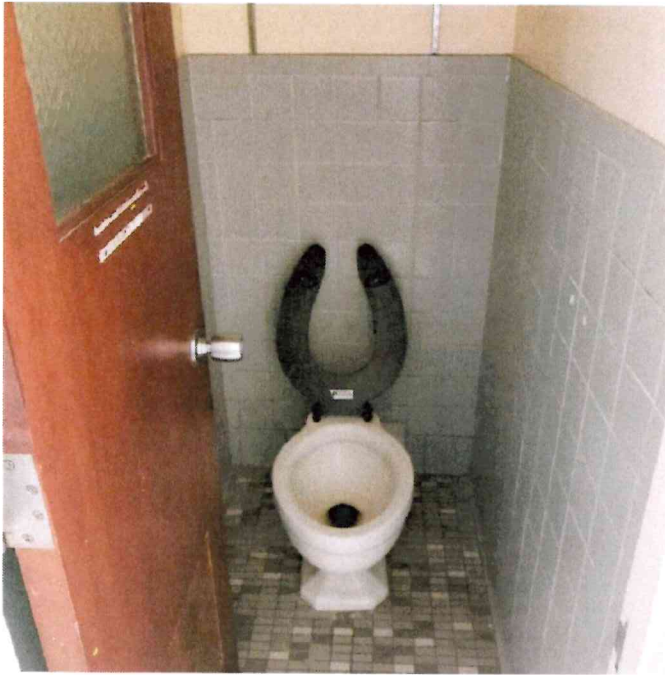
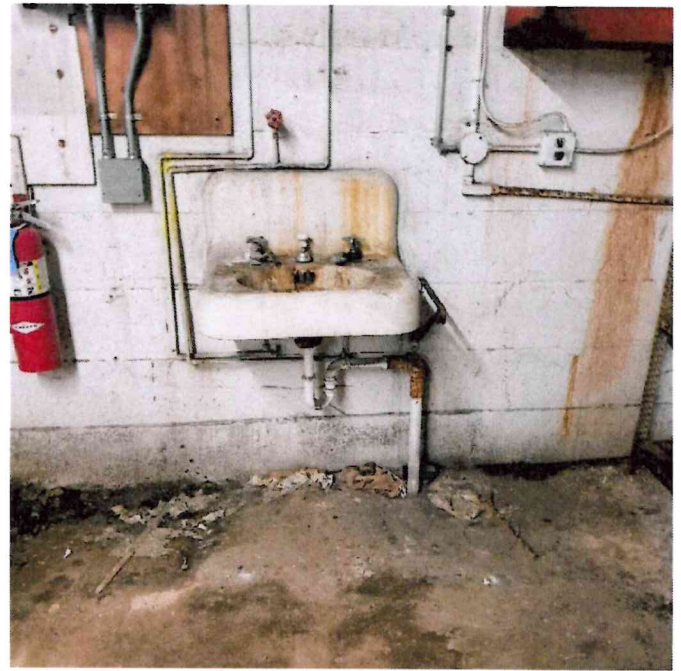
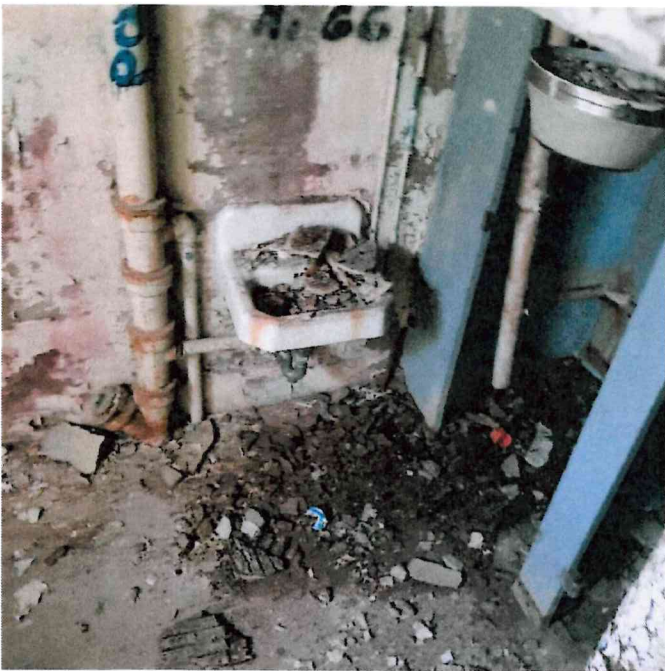
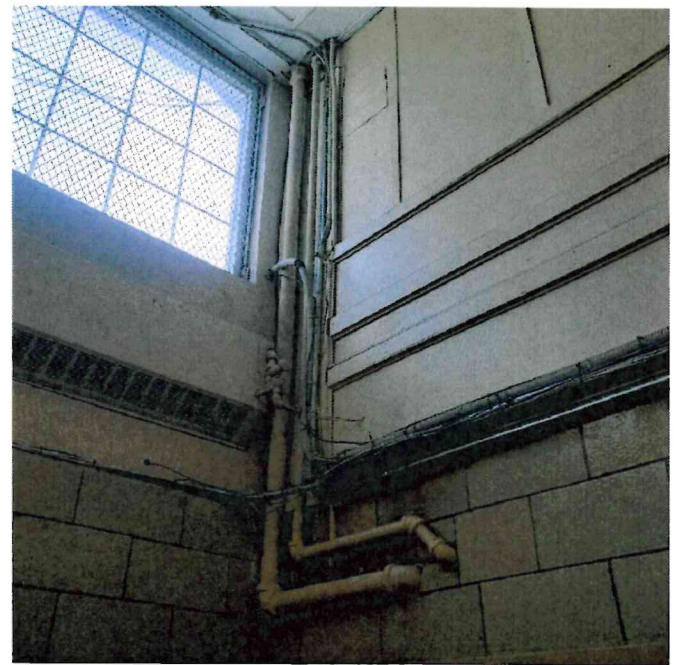
The facility is provided with a 50-gallon electric water heater manufactured by AO Smith, model ENS-50-110 which serves the buildings plumbing fixtures. The heater is in fair condition.

Remove all existing plumbing fixtures throughout the facility including all water closets, classroom sinks, urinals, lavatories, shower, mop sinks, and all kitchen fixtures as they are in poor condition. Provide new fixtures per the new architectural program. Provide new hot water, cold water, sanitary and vent services to new fixtures as indicated in the new architectural layout.

It is recommended to remove the existing electric water heater, pump, tank, valves, etc. as they are past their serviceable life expectancy and replace them with a new code compliant system.
