John Pettibone Community Center Building

Building Conditions Assessment

2 Pickett District Road New Milford, Connecticut 06776

Draft Report, February 23, 2024 Final Report, March XX, 2024

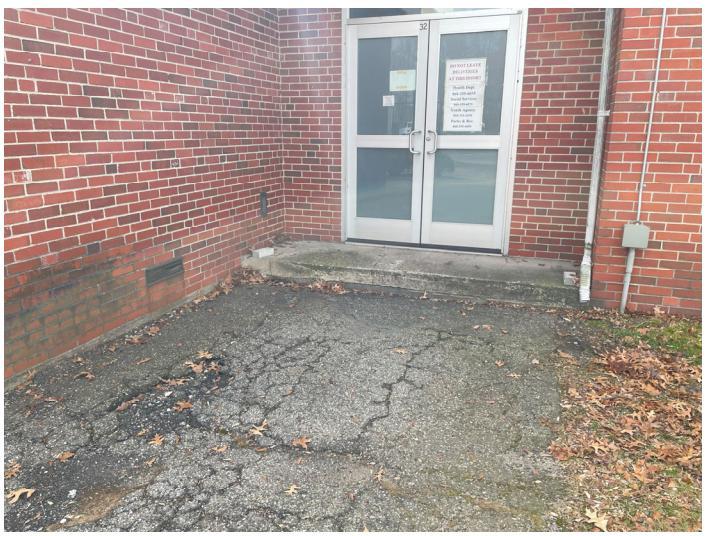
Typical bituminous sidewalk condition. Note step at door

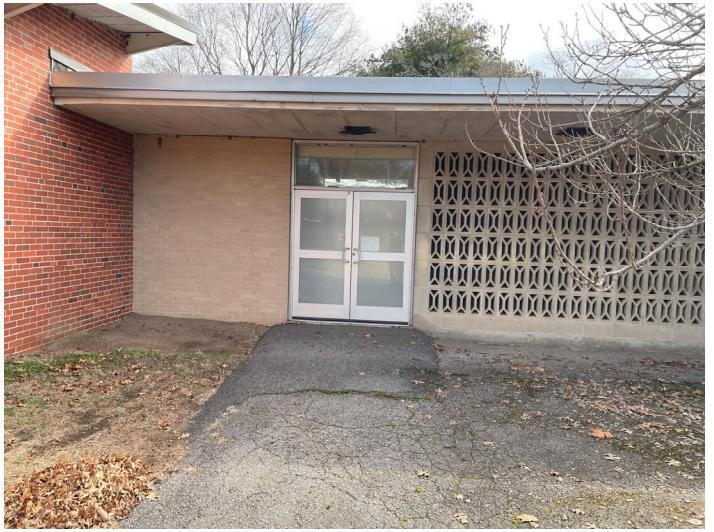
Bituminous sidewalk condition. Step at door too high

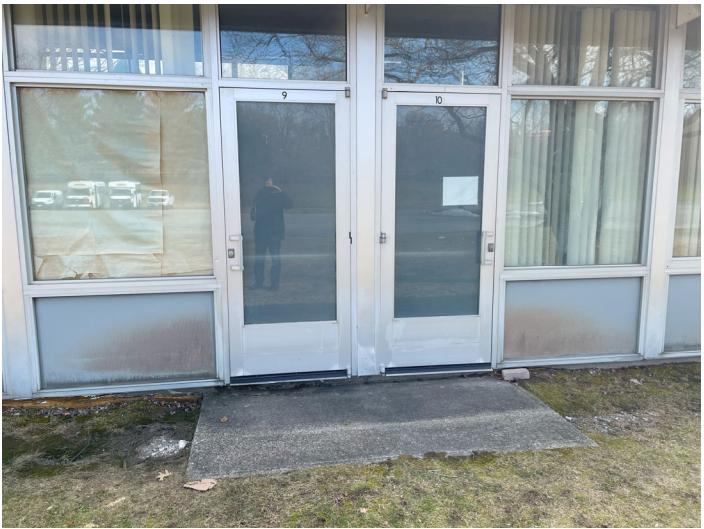
Concrete stoop doesn't connect to sidewalk. Step too high

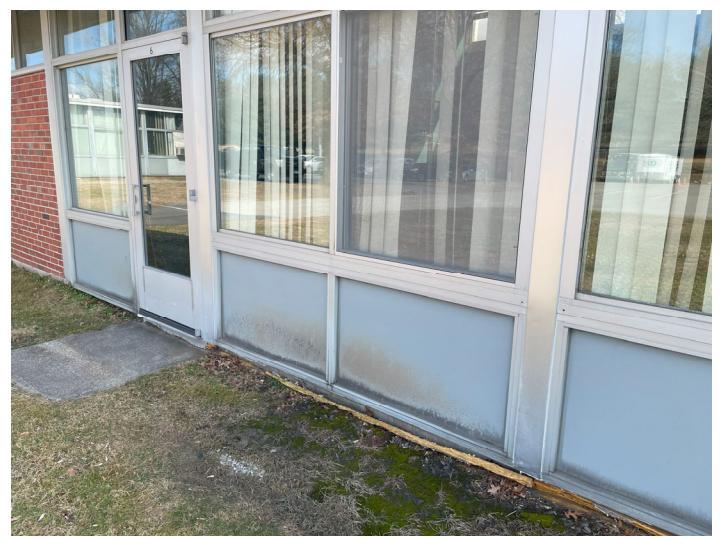
Bituminous stoop doesn't connect to sidewalk. Step too high

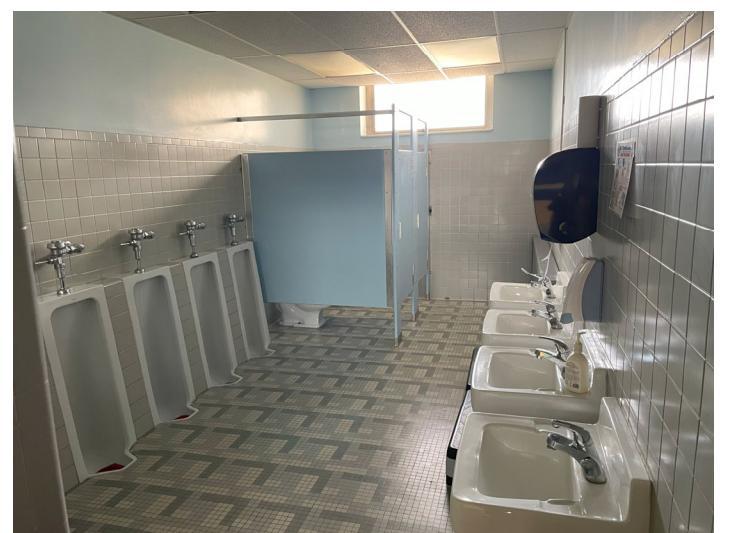
Typical non ADA compliant toilet room

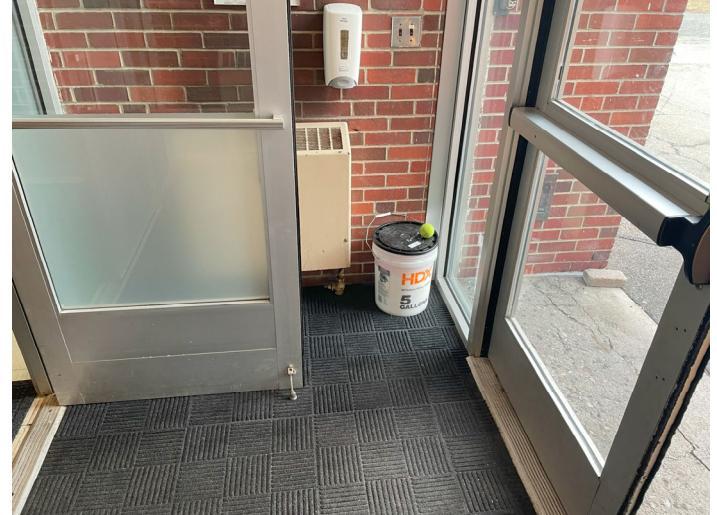
Typ. vestibule in exist. building. Too shallow between doors

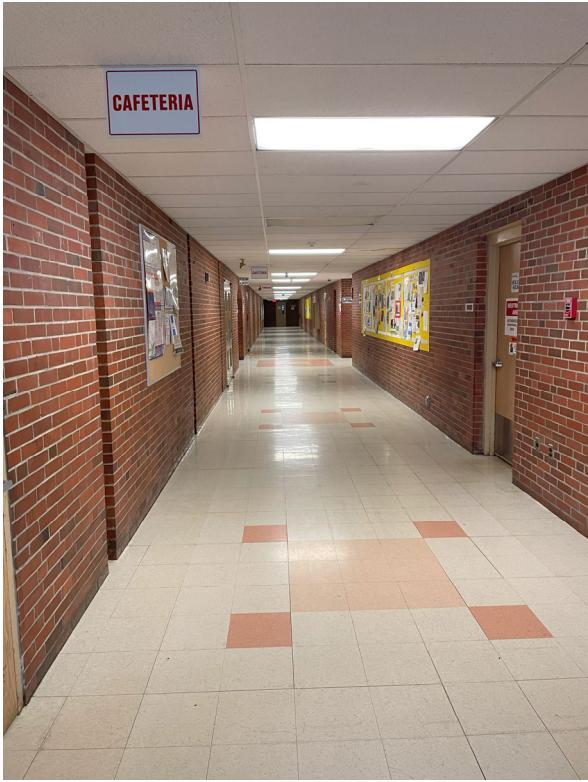
Corridors: the corridors are predominately 12"x12" VCT tile in poor condition with loose tiles in many locations. Walls are mostly painted masonry (some locations have exposed red brick) and ceilings are mostly 2x4 ACT in poor condition. New flooring, paint & new ceilings are being recommended.

Typical hallways materials/condition

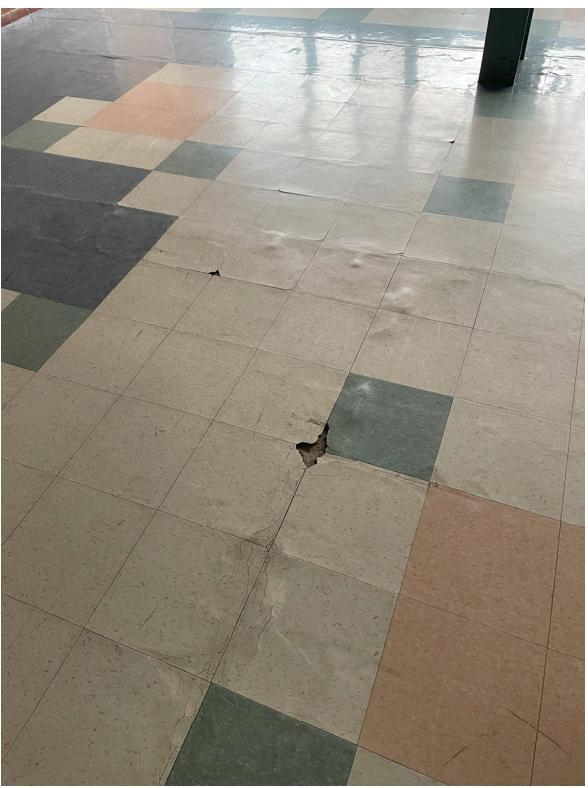
Cafeteria: The existing cafeteria has 12"x12" VCT floor tile in poor condition with loose tiles in many locations. There are also significant cracks causing tripping hazards in this space. Walls are mostly exposed red brick and ceilings are exposed painted sloped tectum panels. New flooring & paint for the walls & ceiling is recommended.

Cafeteria VCT flooring condition

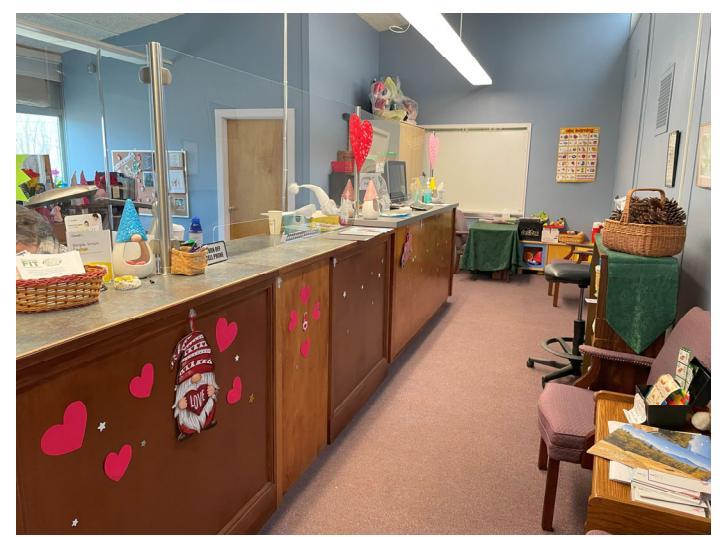
Counter condition - Social Services. No ADA compliance

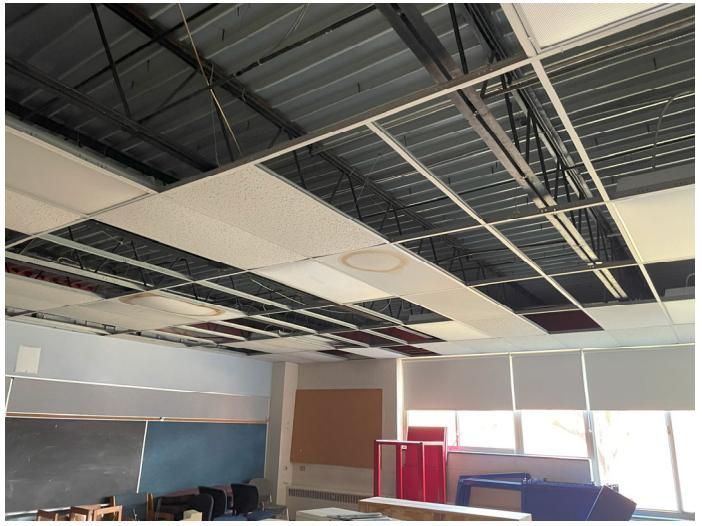
Typical Classroom ceiling condition

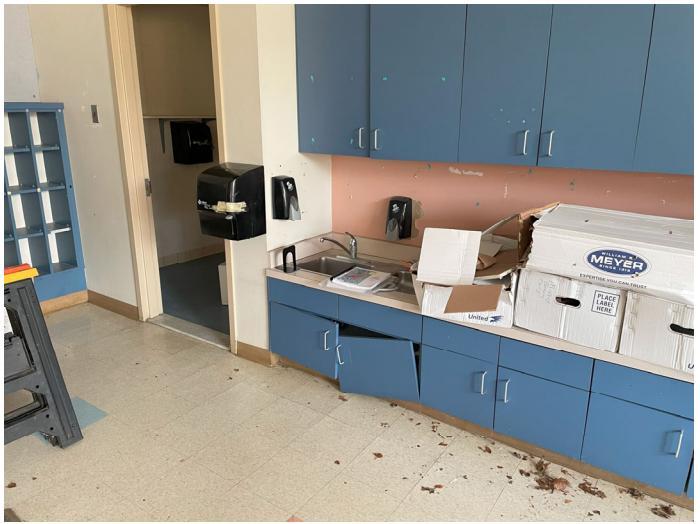
Typical classroom casework/ sink condition

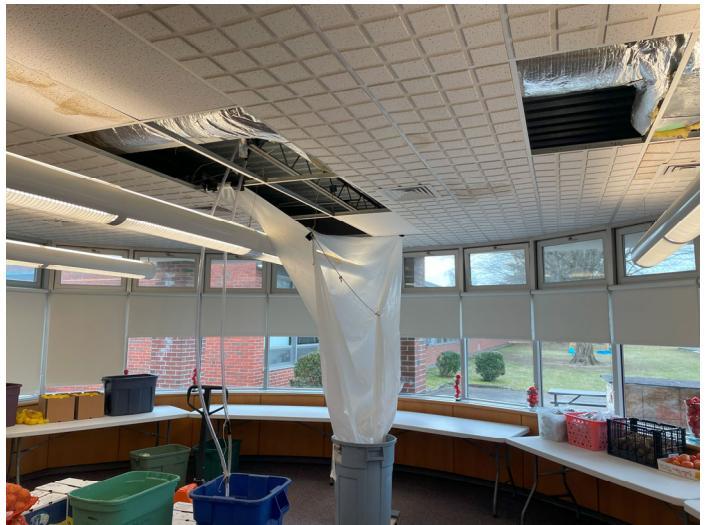
Media Center: The existing media center has carpet flooring in very poor condition with many sections completely missing. The walls are painted concrete block or painted gypsum board. The ceiling is mostly 2x4 ACT and is poor condition with many tiles missing from roof leaks. It is recommended that all carpet and ACT ceiling be replaced with new paint on all wall surfaces.

ceiling condition in Media Center - significant roof leaks.

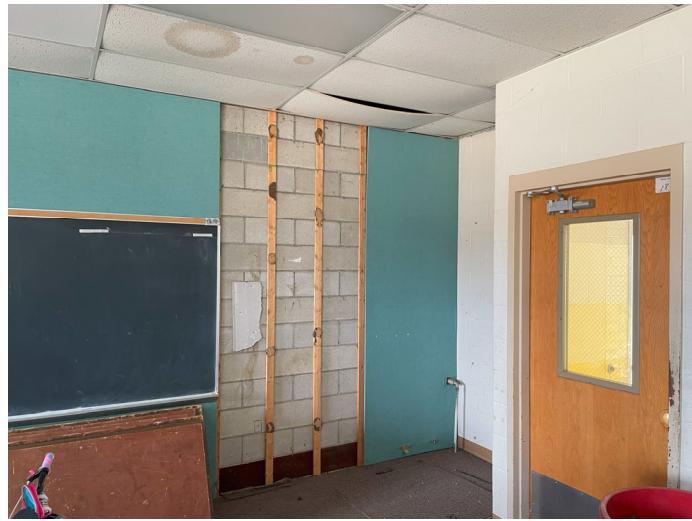
wall/ceiling condition in classroom

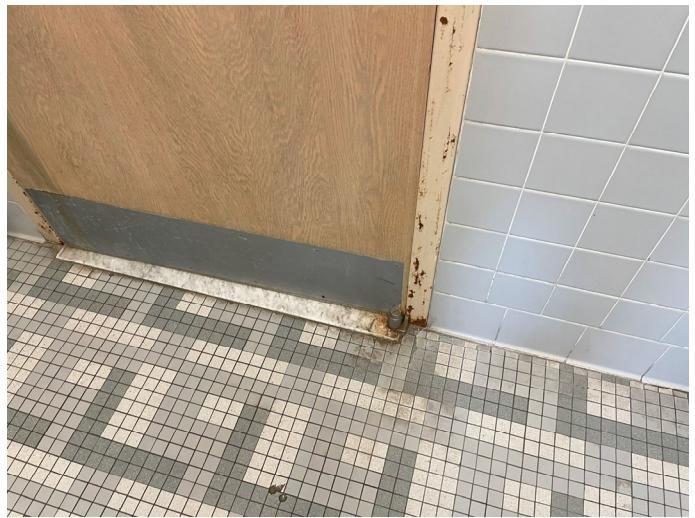
Many HM door frames in wet condition showing rust.
