**PHASE IA ARCHAEOLOGICAL
SURVEY**

**NEW MILFORD RIVER TRAIL
NORTHERN AND SOUTHERN
SECTIONS**

**BOARDMAN ROAD TO
BROOKFIELD BORDER**

NEW MILFORD, CONNECTICUT

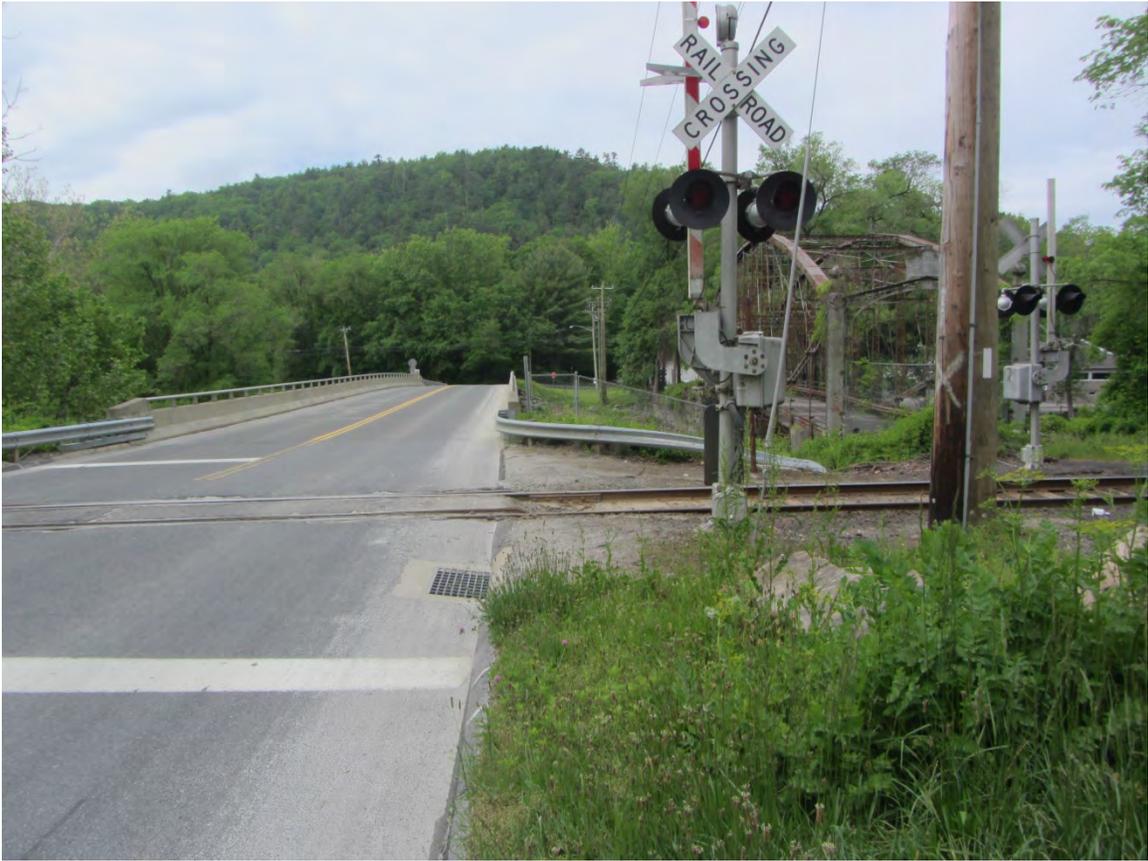
Photograph N1: Boardman Road facing east from north side of road to railroad tracks, with the existing Boardman Bridge at left and the historical 1888 wrought-iron, lenticular truss Boardman Bridge (National Register of Historic Places) at right.

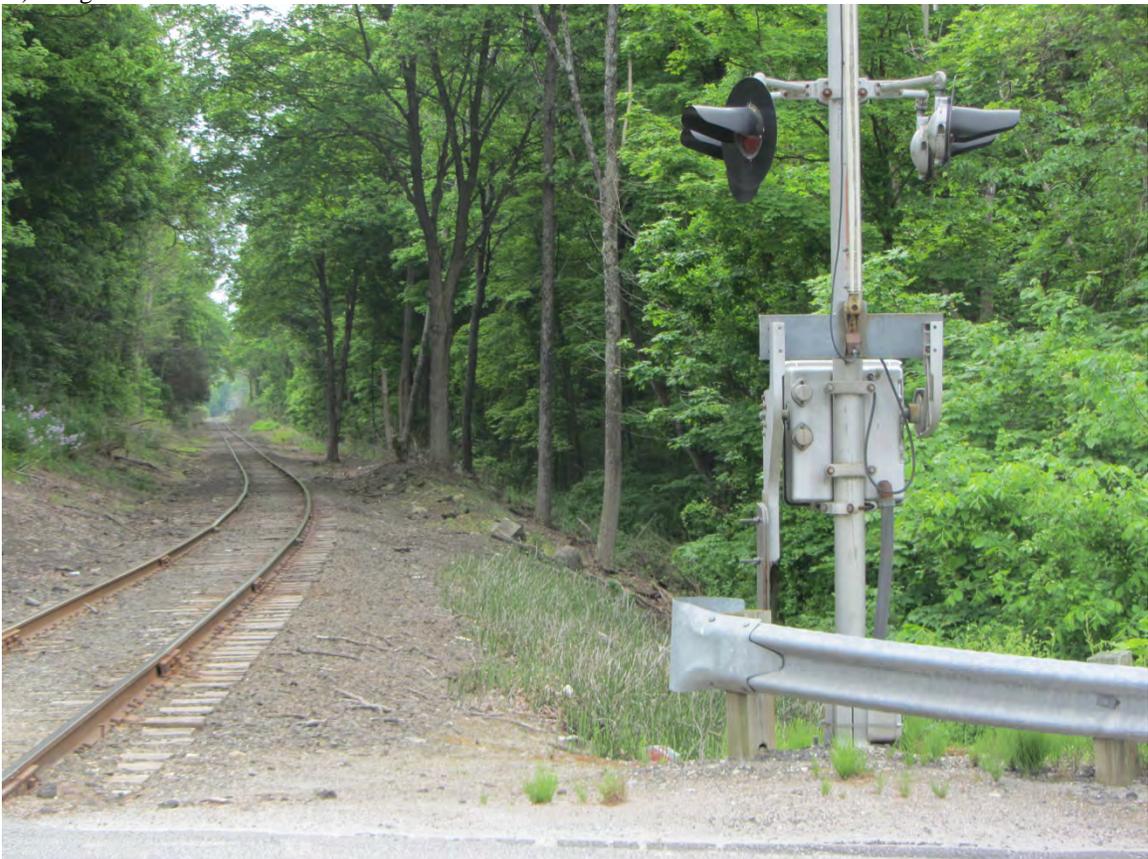
Photograph N2: Railroad tracks facing south Boardman Road toward northern terminus of the proposed River Trail, Northern Section. Note: The grade slopes steeply down to the river, at right, and is heavily wooded.

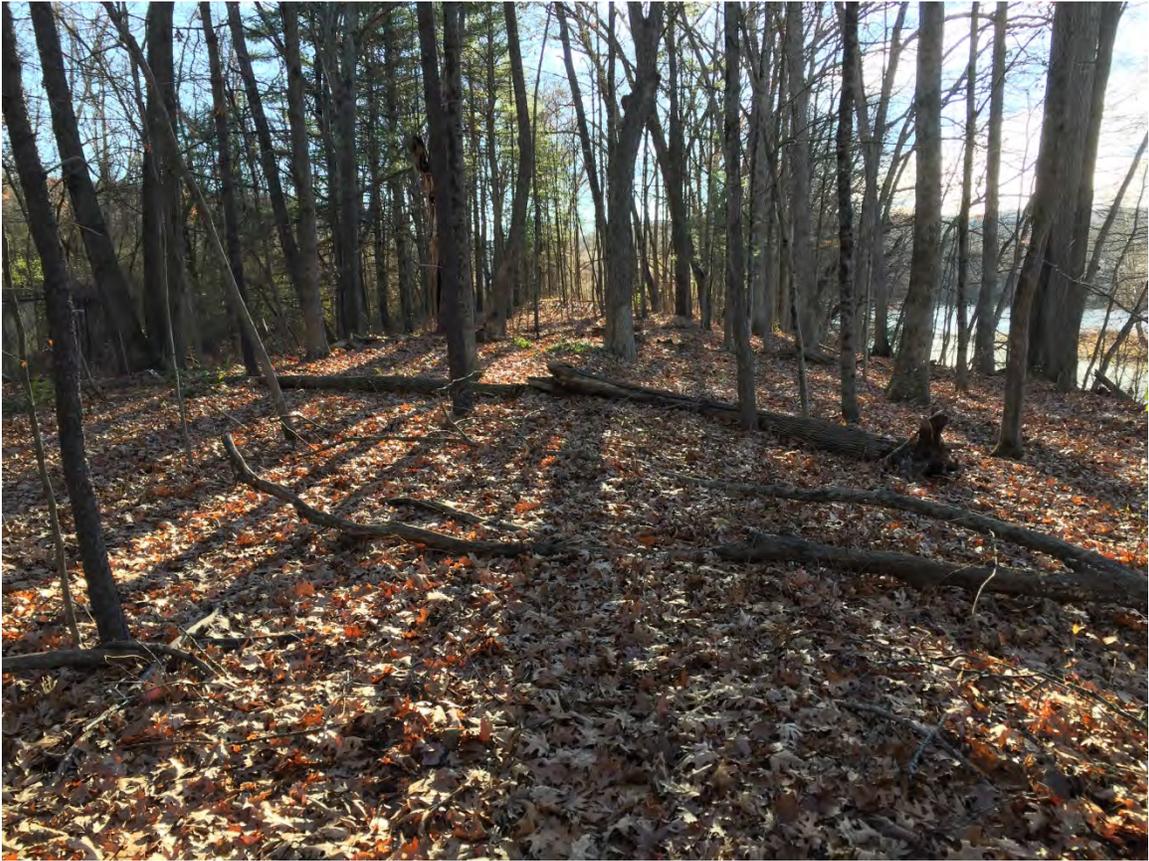
Photograph N3: Facing south to a level terrace between the Housatonic River, at right, and railroad tracks to the left and out of the photograph. This area is wooded and has a semi-cleared path, possibly an abandoned road used for access to fishing spots or for nineteenth-century railroad construction.

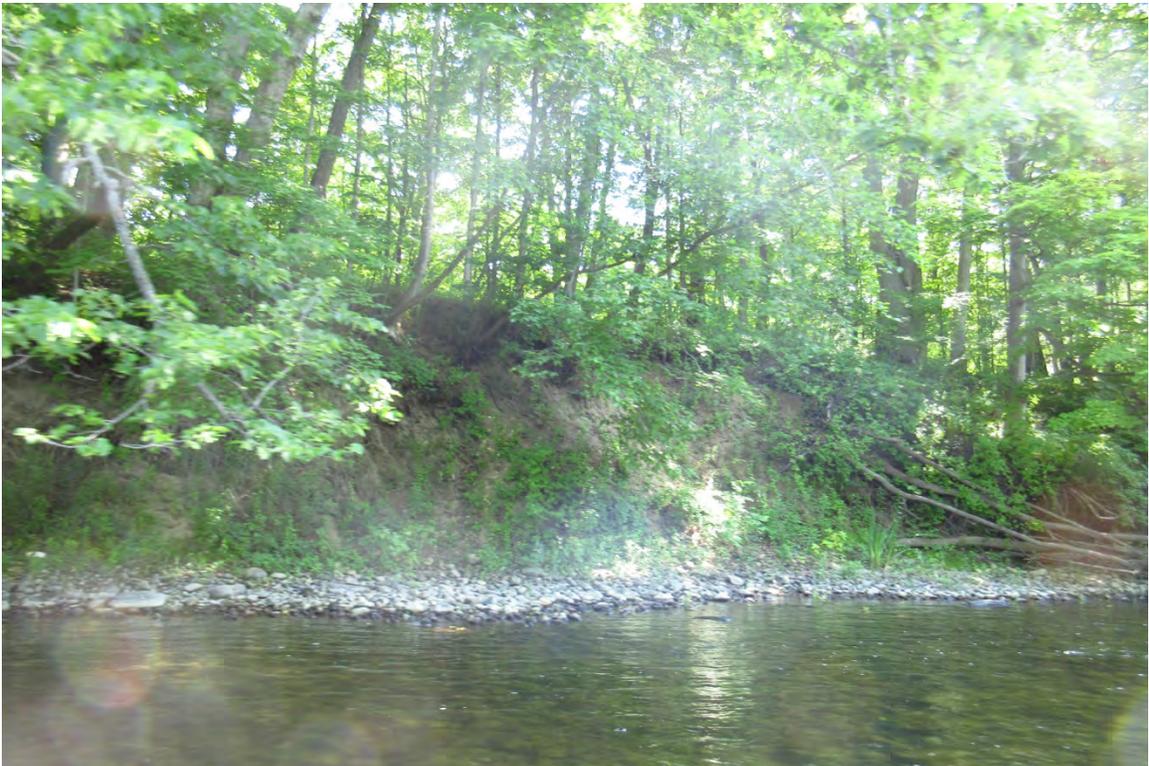
Photograph N4: MEDInstill property with a steep embankment along the east side of the Housatonic River, facing southeast.

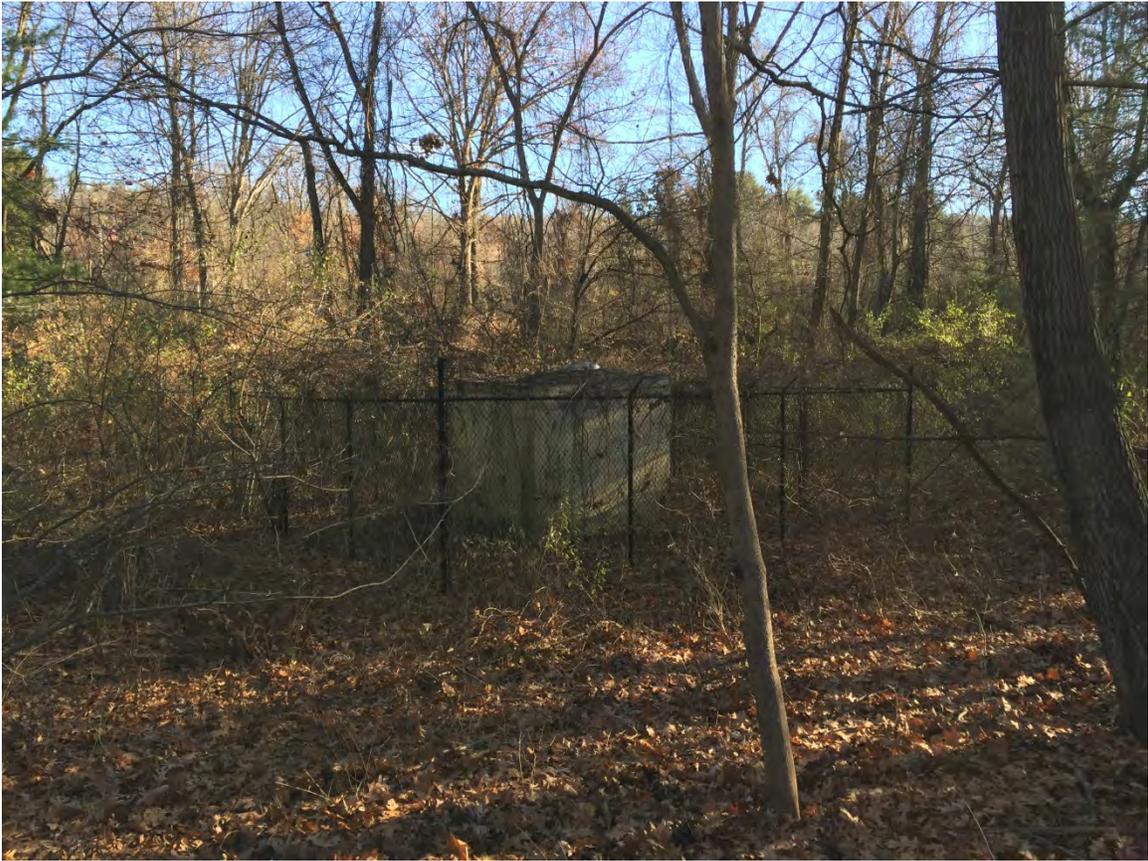
Photograph N5: Level terrace between the Housatonic River and the railroad tracks, facing east to a small fenced-off area with a concrete structure, located on MEDInstill property.

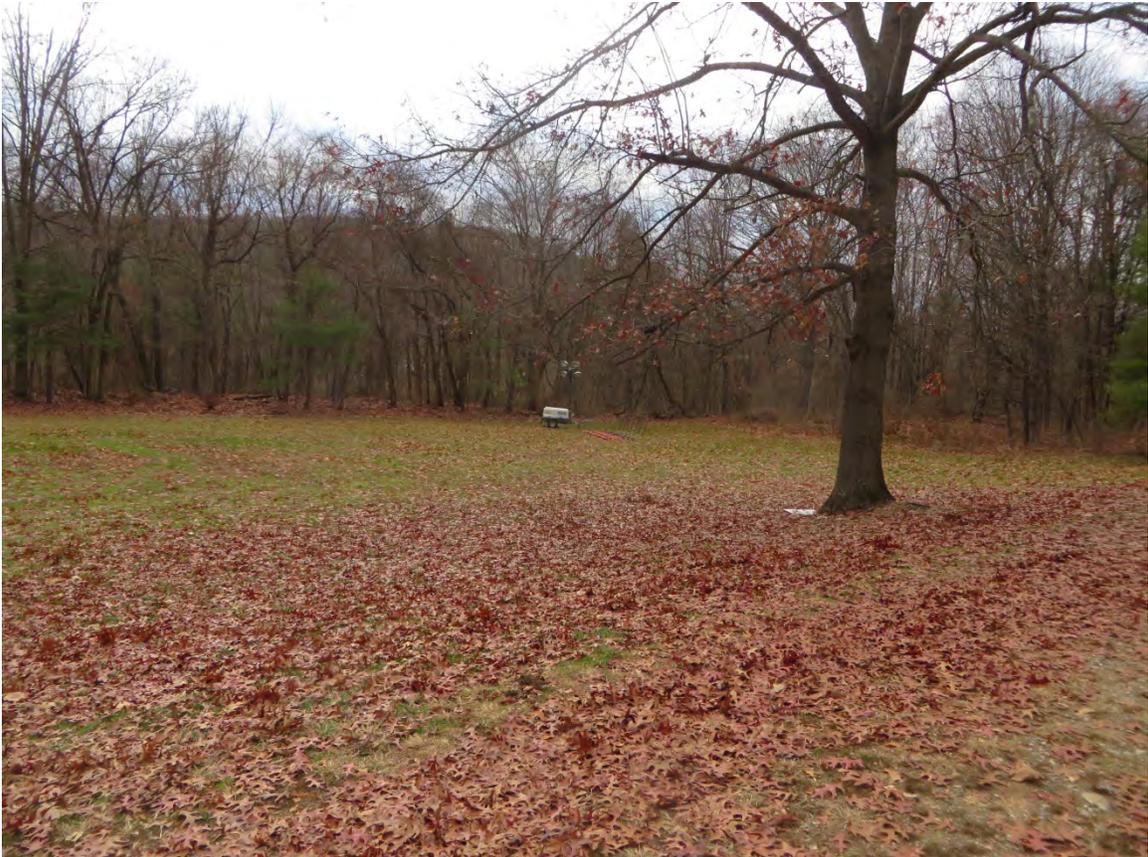
Photograph N6: Facing northeast to a relatively level field immediately east of the railroad tracks north of the MEDInstill property.

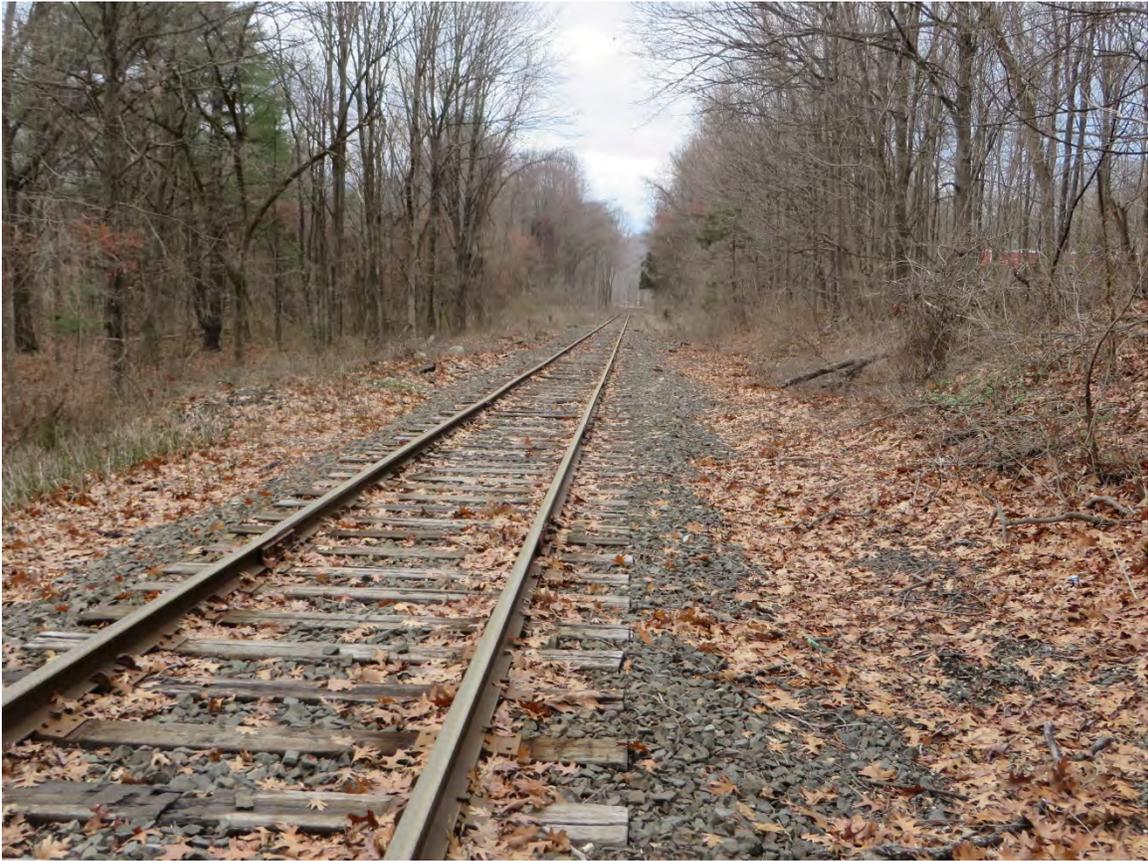
Photograph N7: Facing north to railroad cut into the terrain, with an embankment down at left, and an embankment up at right.

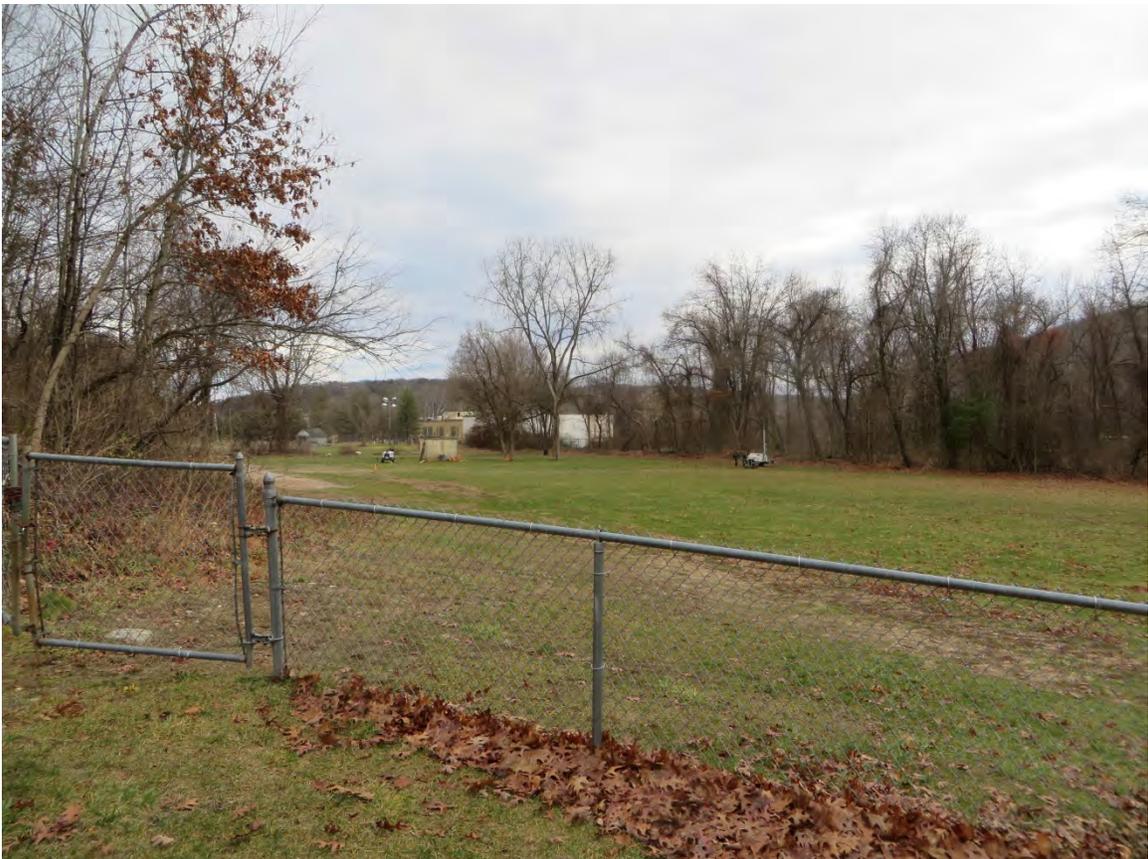
Photograph N8: Facing southwest to a field at the north end of MEDInstill property, east of the railroad tracks.

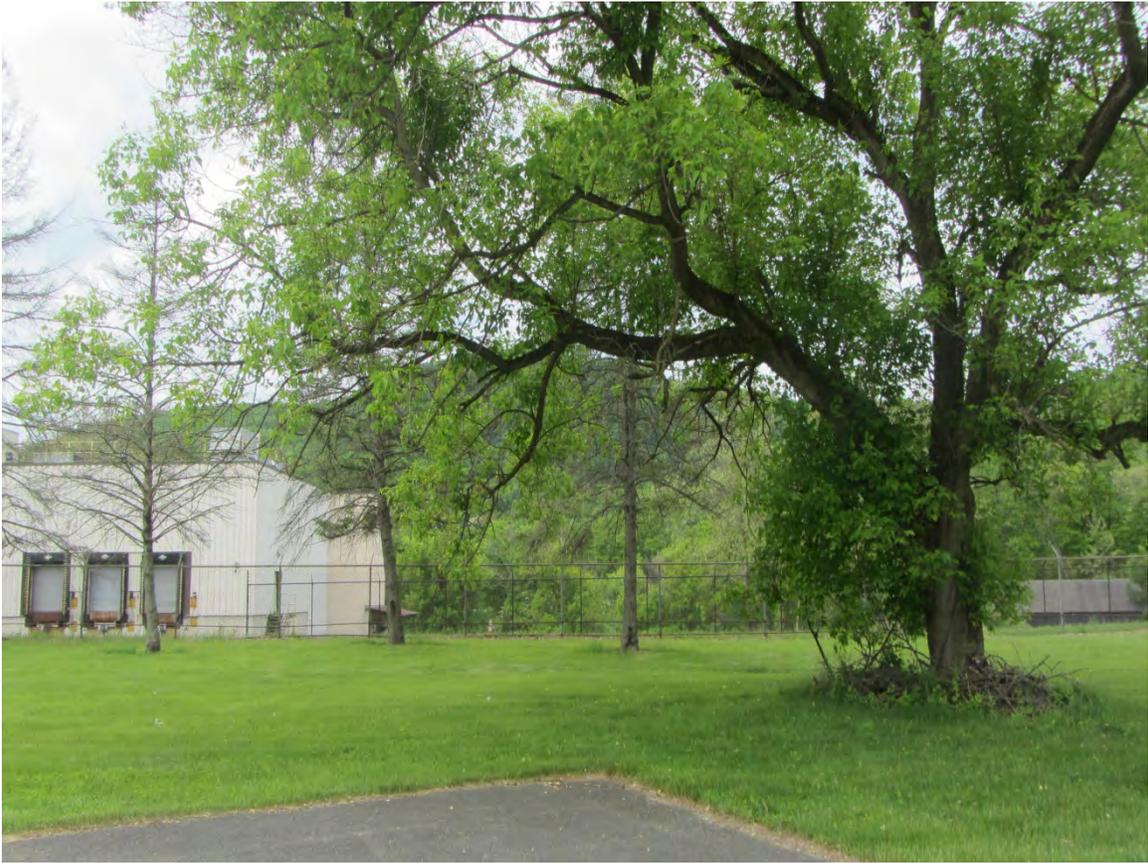
Photograph N9: Facing southwest toward two unused buildings at the north end of the MEDInstill property, both to the west of the railroad tracks.

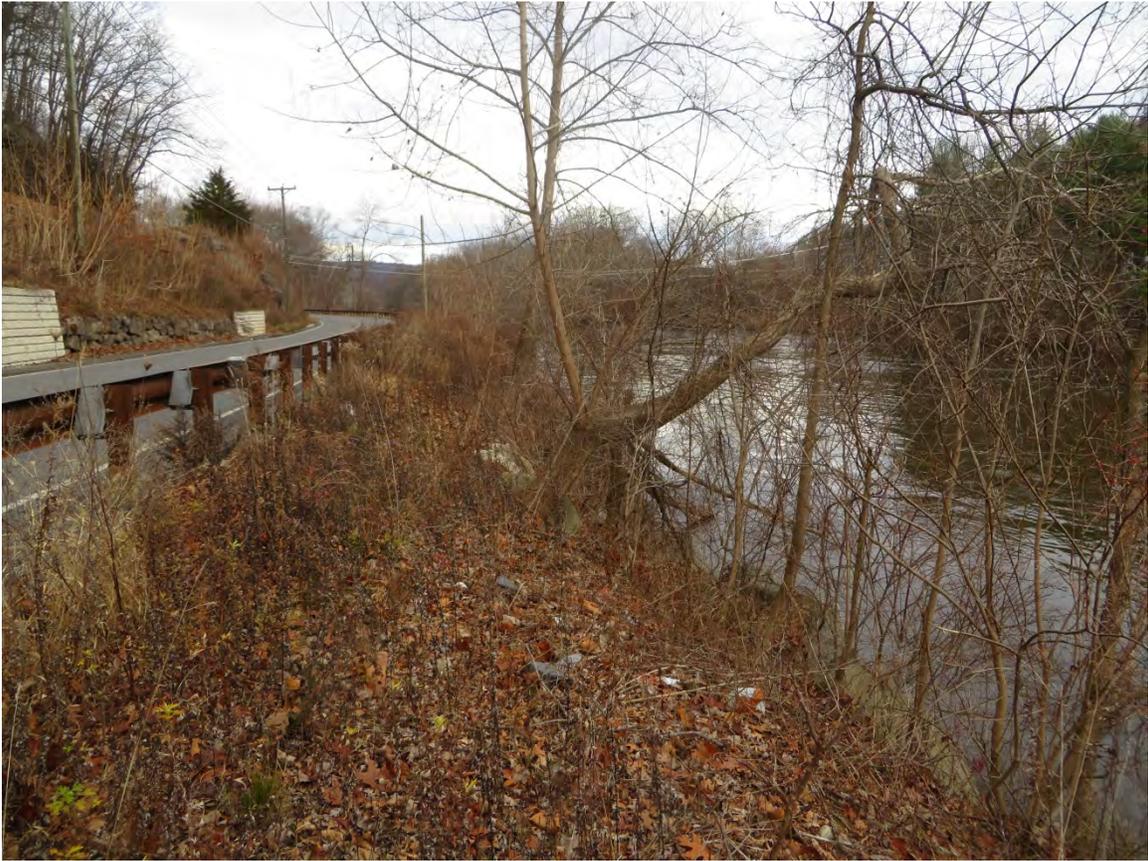
Photograph N11: Facing east to a narrow “choke” point where, from left to right, the railroad tracks, Boardman Road, and the Housatonic River closely align.

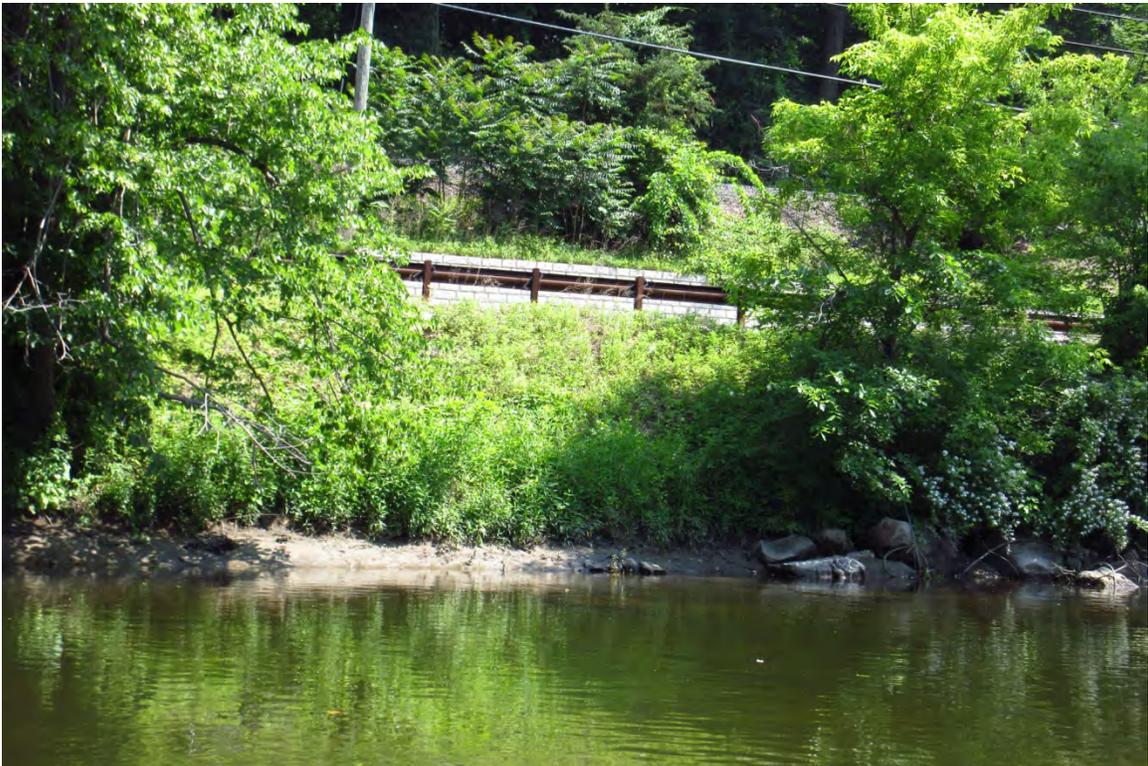
Photograph N12: Facing north from the Housatonic River to a point where the railroad tracks and Boardman Road closely align. The trail may be elevated on piles along the south side of the road here.

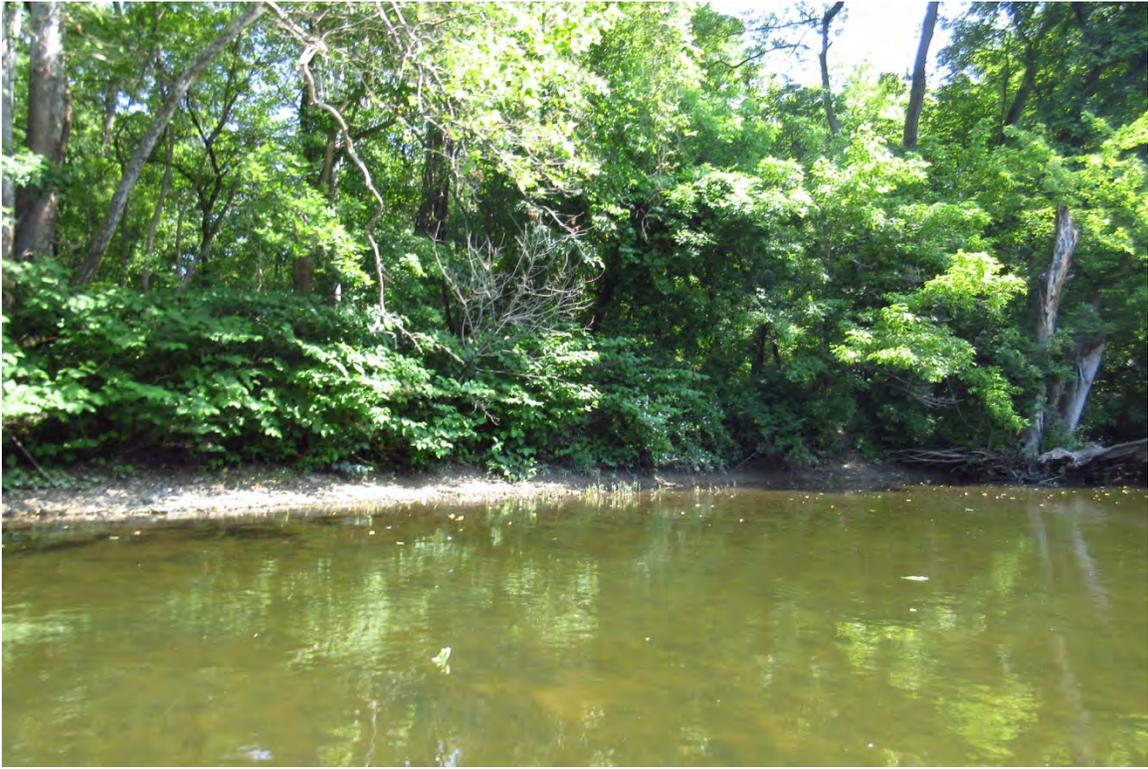
Photograph N13: The west side of the seasonally flooded Wannuppee Islands, facing northeast from the Housatonic River.

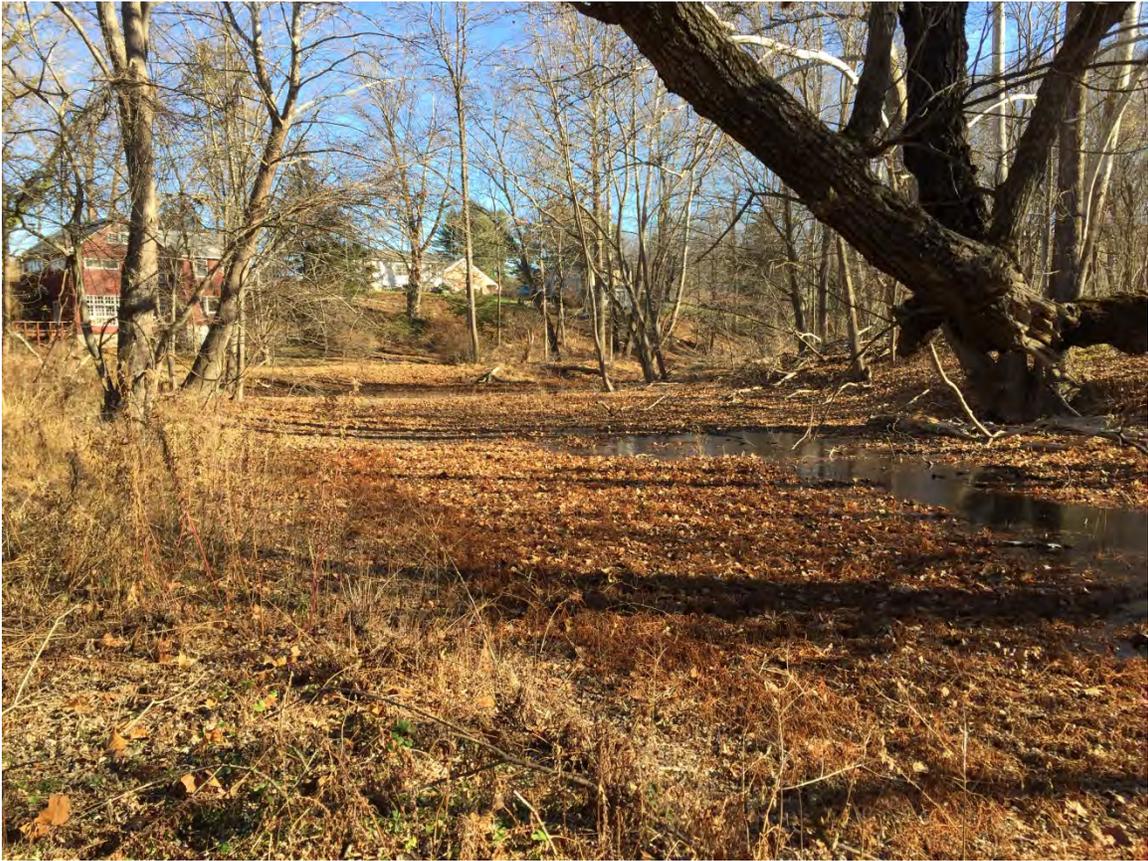
Photograph N15: Flooded area separating Wannuppee Island from the upland terrace and the course of Housatonic Avenue, facing northeast.

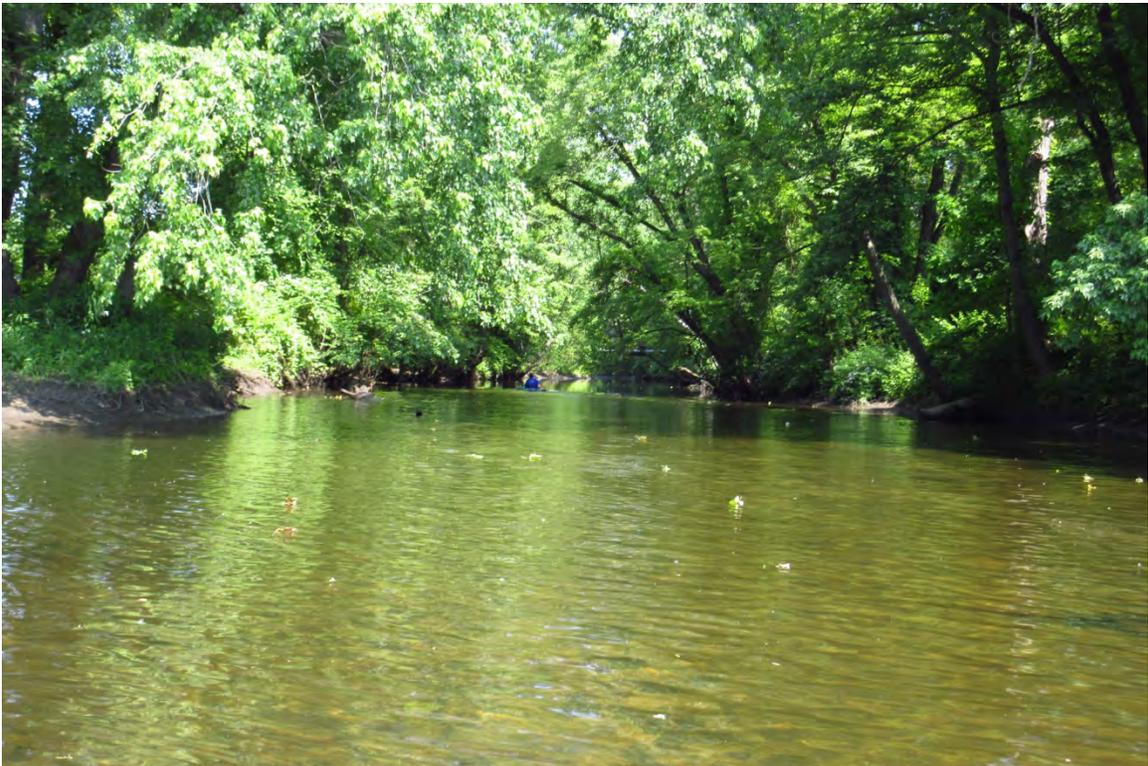
Photograph N18: The confluence of the West Aspetuck River and the Housatonic River, facing north up the West Aspetuck River. The Housatonic Avenue bridge is barely visible in the background.

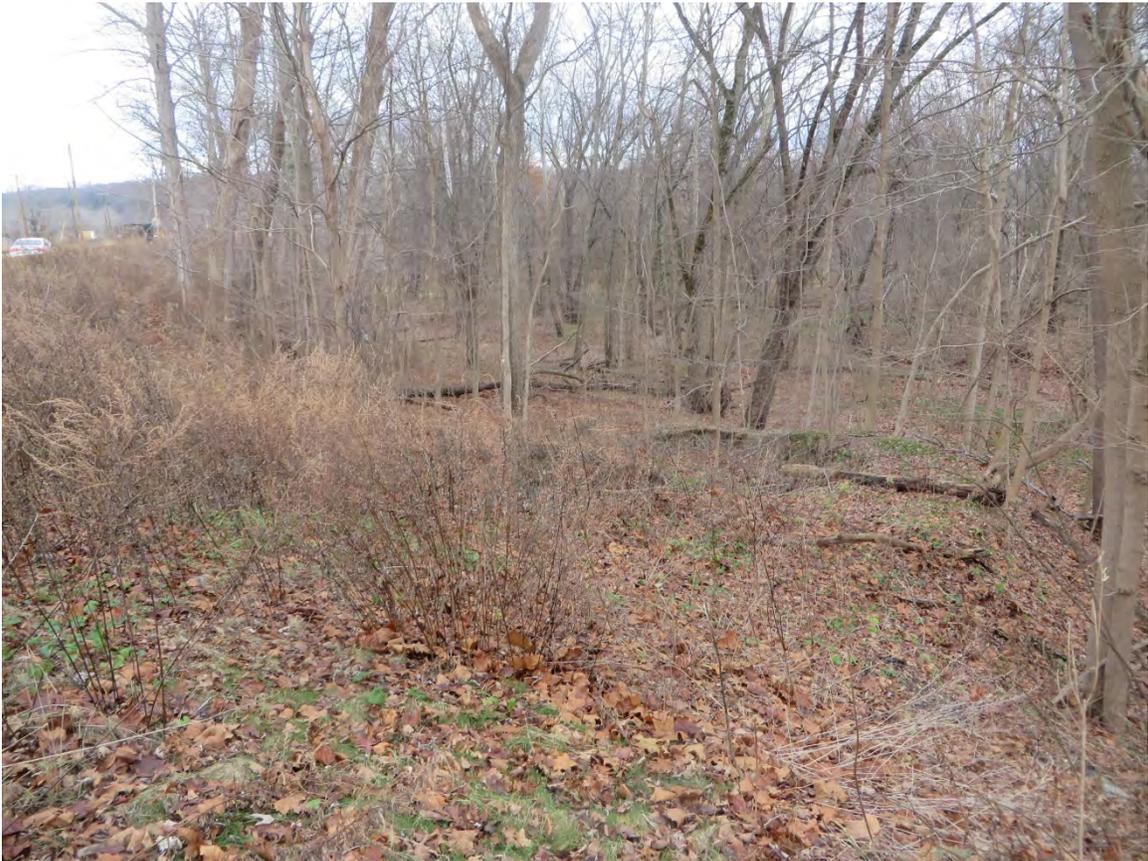
Photograph N20: Wooded area on the south side of Housatonic Avenue and east of the choke point where the road, railroad tracks, and river are in close proximity, facing south.

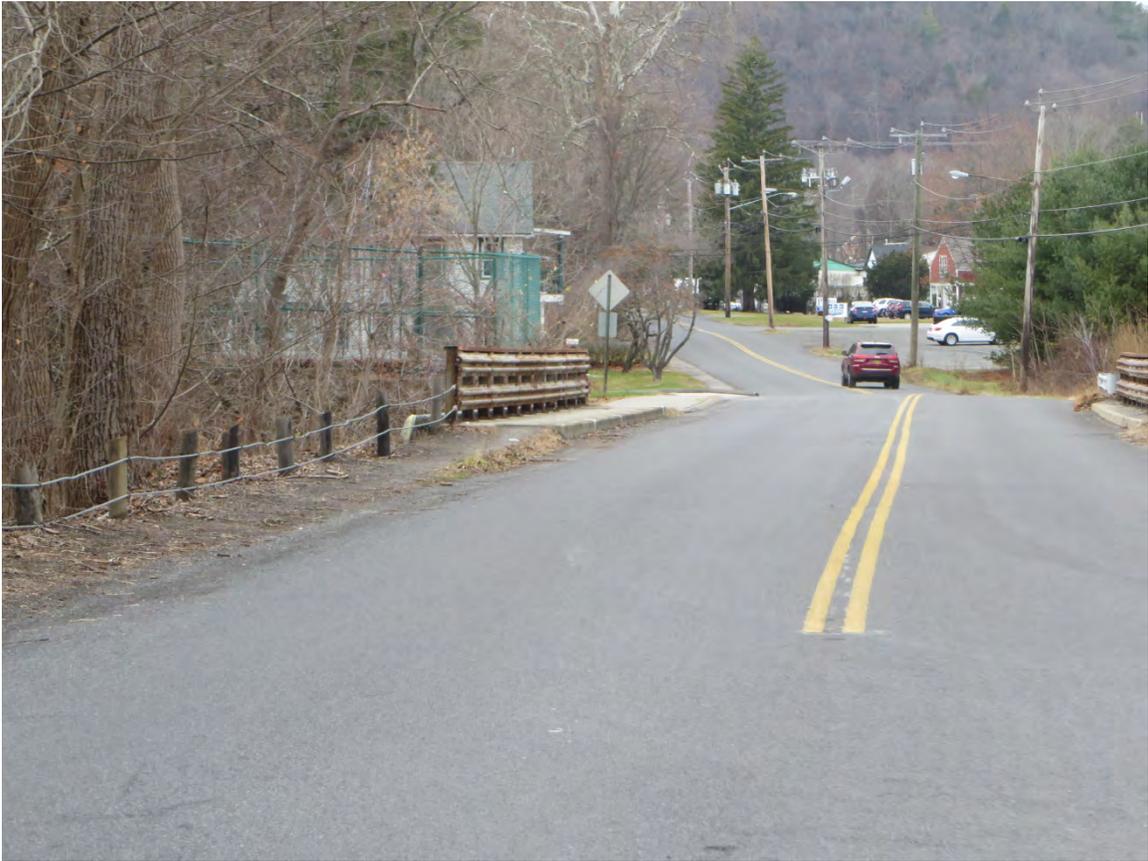
Photograph N22: Facing northwest from the center of Housatonic Avenue toward a small bridge crossing over the West Aspetuck River.

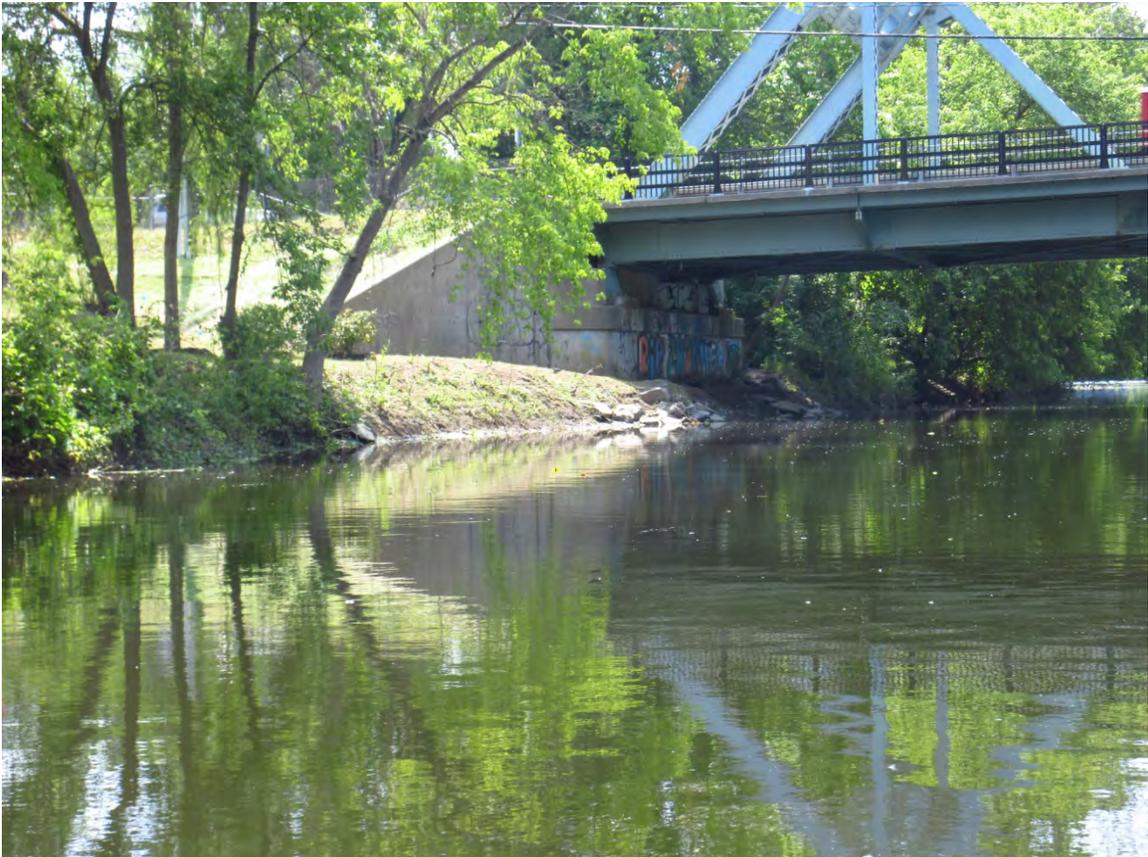
Photograph S6: Potential route of trail beneath the east side of the Bridge Street Bridge, immediately adjacent to the Housatonic River, facing southeast.

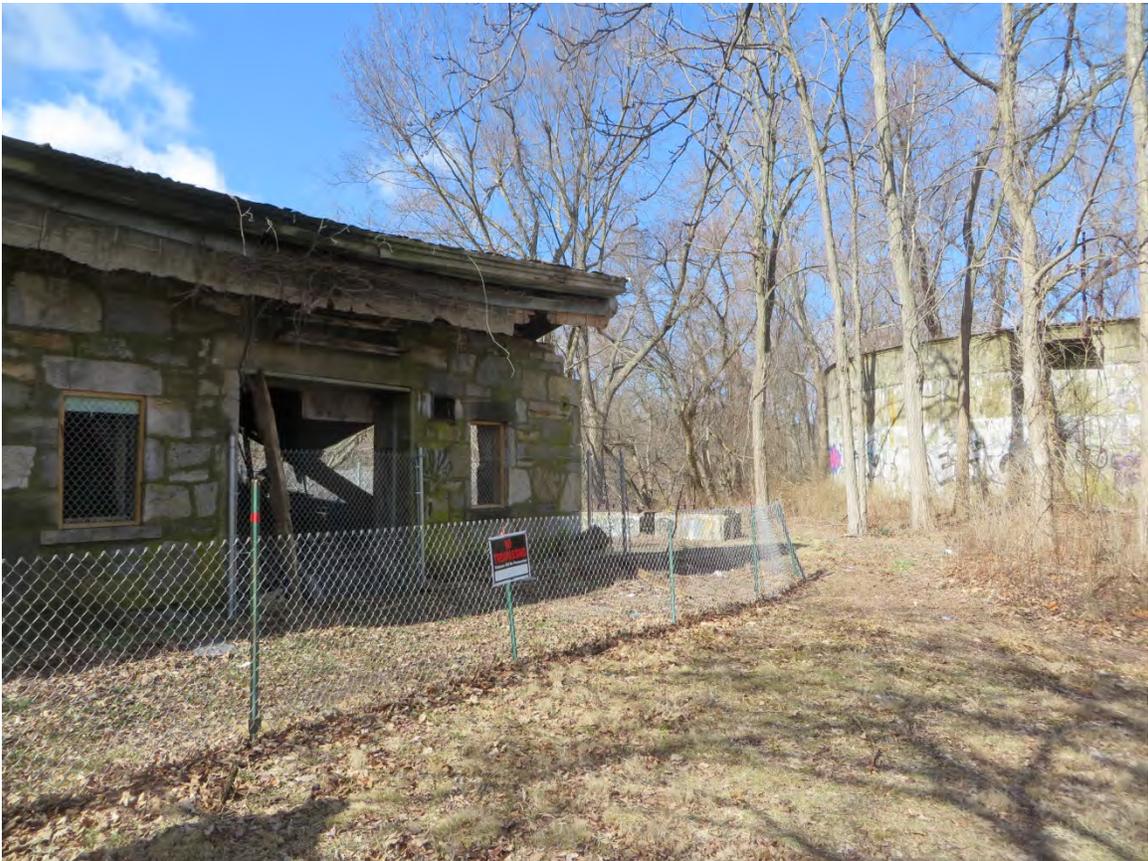
Photograph S8: East façade of old granite and fieldstone mill building in Hidden Treasures Park, with storage tank to the north.

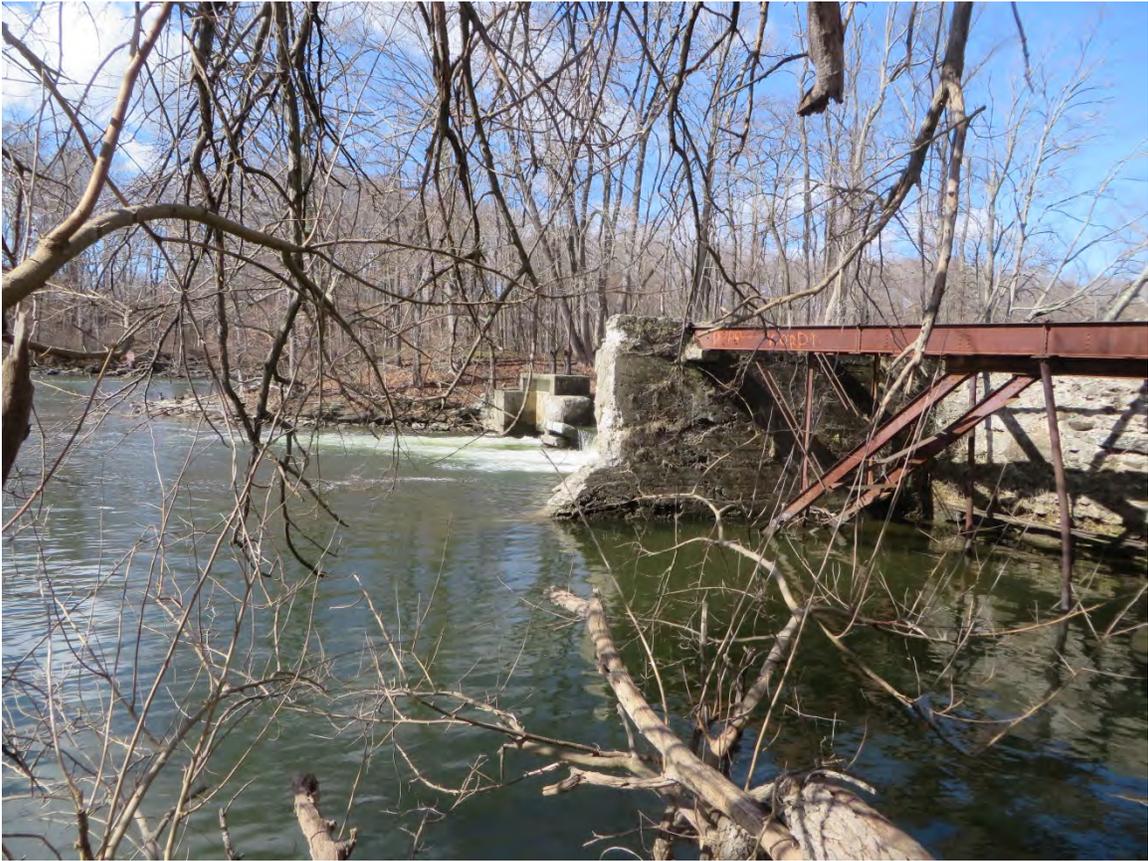
Photograph S9: Remains of eastern portion of Bleachery Dam adjacent to the mill building in Hidden Treasures Park, facing northwest.

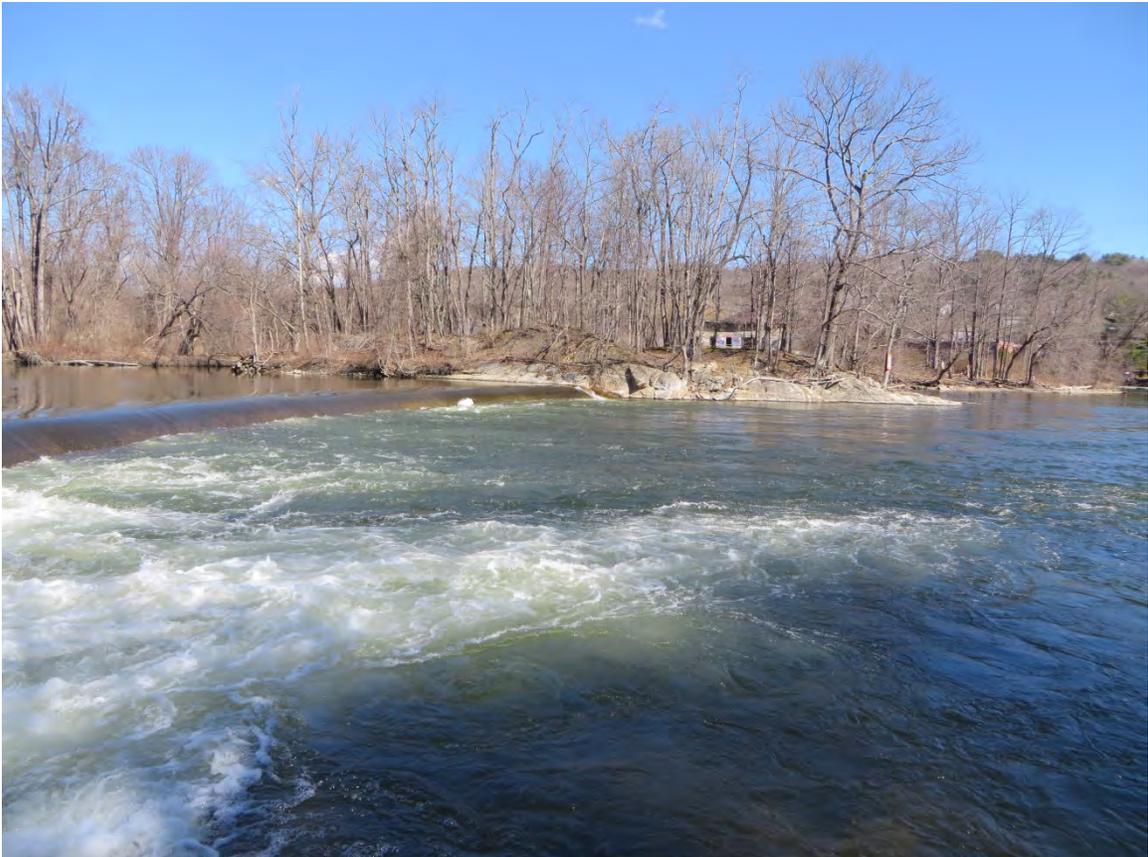
Photograph S10: Facing east from the west bank of the Housatonic River to the western section of the Bleachery Dam on the Housatonic River and, on the opposite side of the river, Hidden Treasures Park.

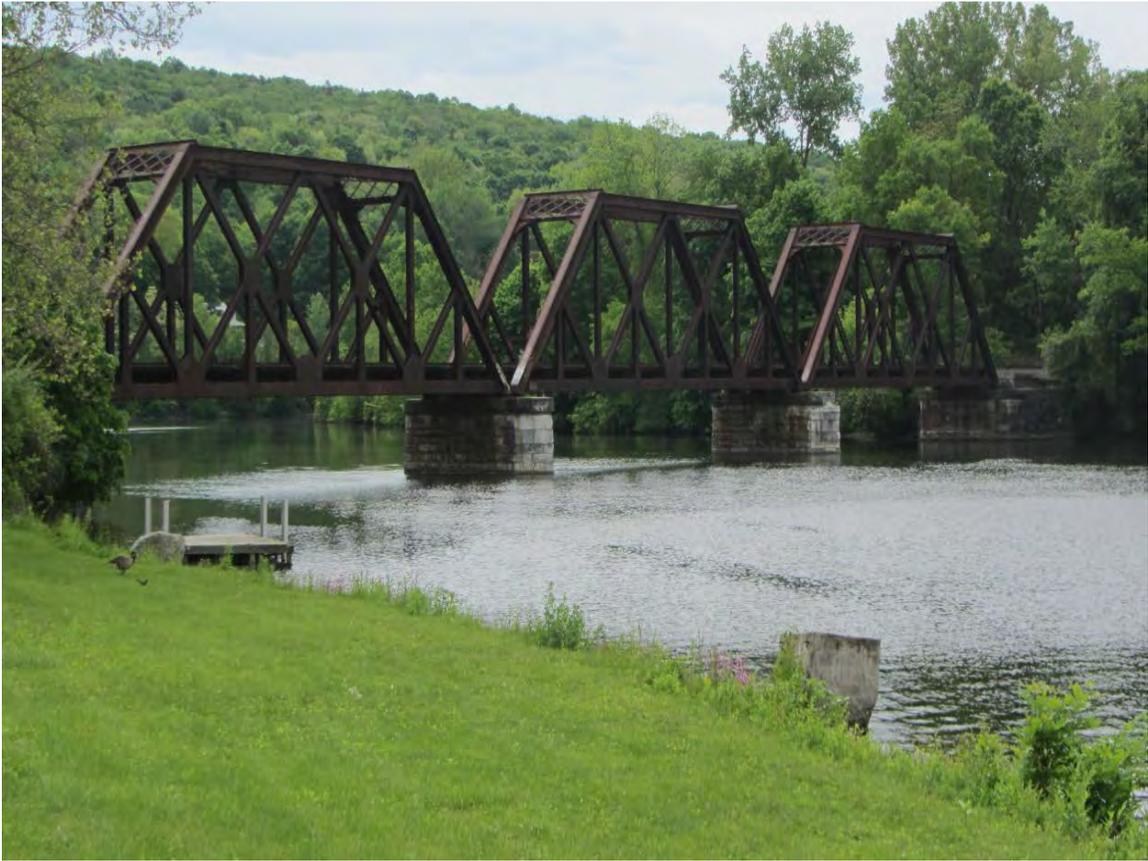
Photograph S11: Existing railroad bridge over the Housatonic River, south of the West Cove Marina property, facing south.

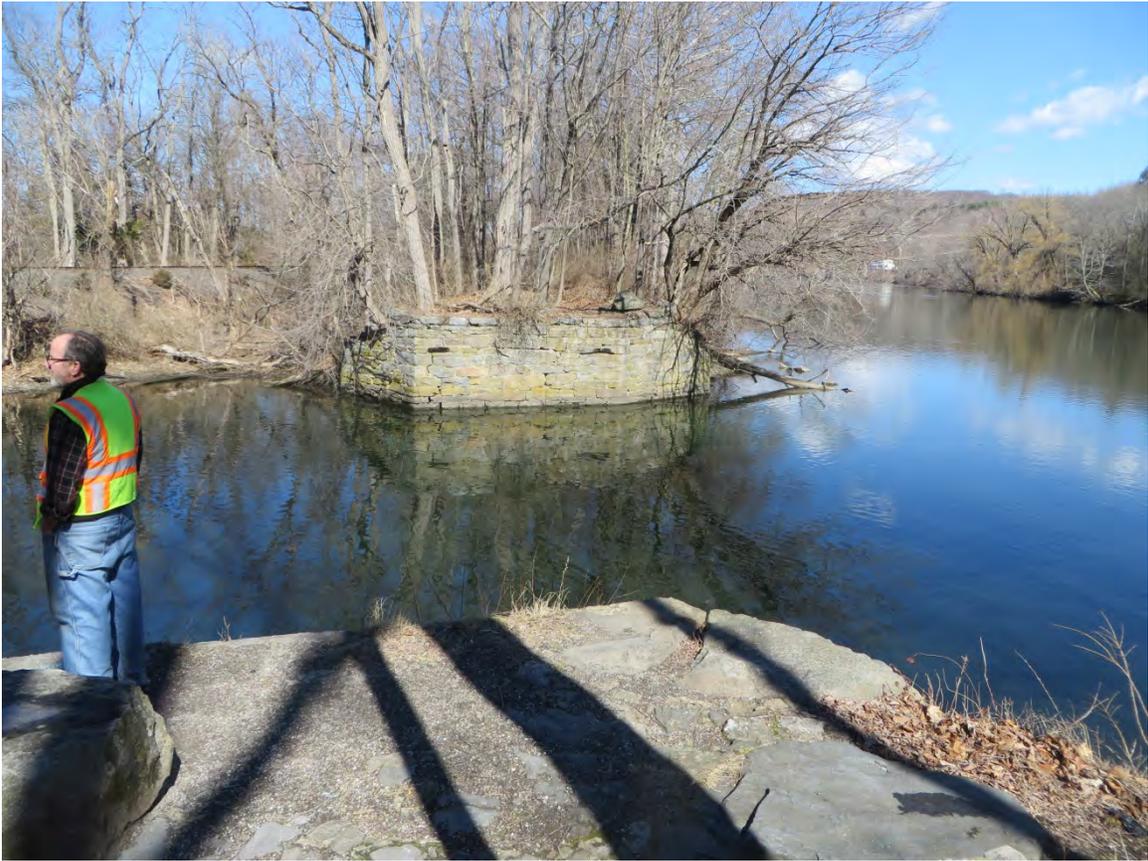
Photograph S17: Historical bridge abutment for former railroad crossing at the mouth of the Still River where it enters into the Housatonic River, facing north.
