**PHASE IA ARCHAEOLOGICAL
SURVEY**

**NEW MILFORD RIVER TRAIL
NORTHERN AND SOUTHERN
SECTIONS**

**BOARDMAN ROAD TO
BROOKFIELD BORDER**

NEW MILFORD, CONNECTICUT

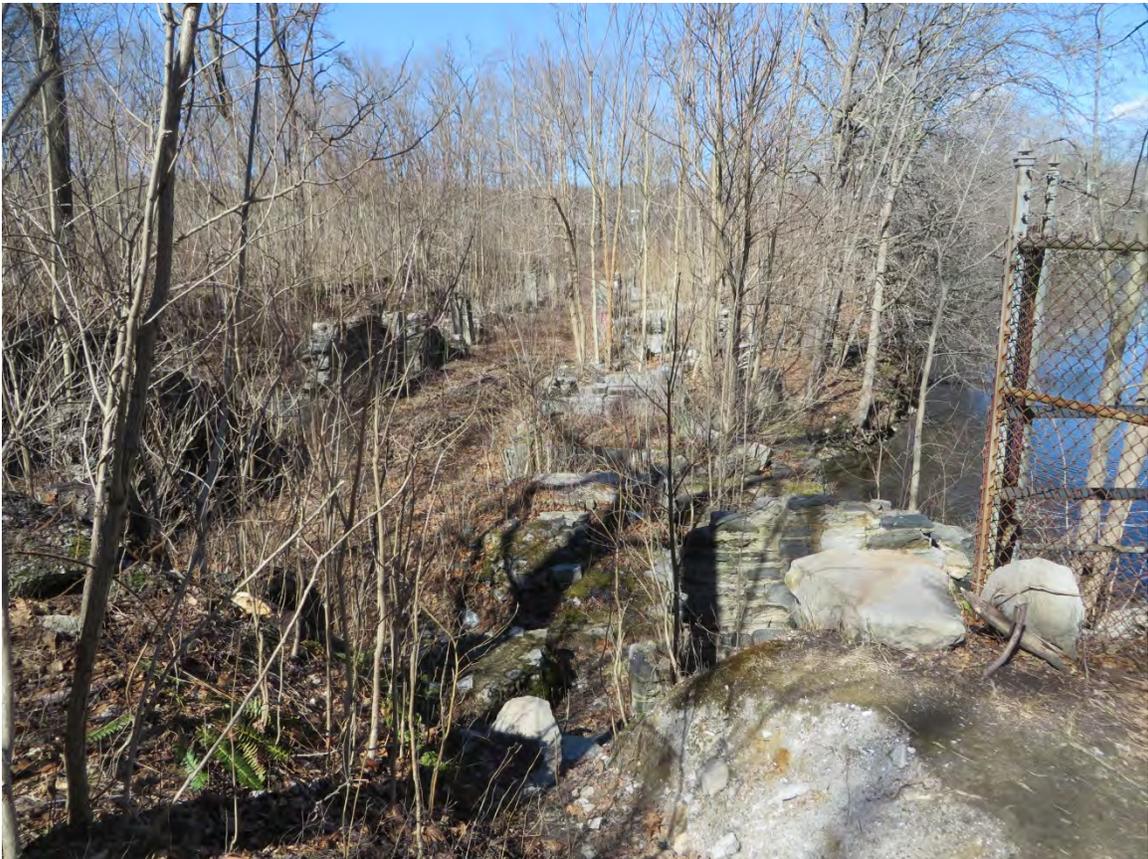
Photograph S18: Facing north to the Bridgeport Wood Finishing Company site, both on the State Register of Historic Places and a Connecticut Archaeological Preserve.

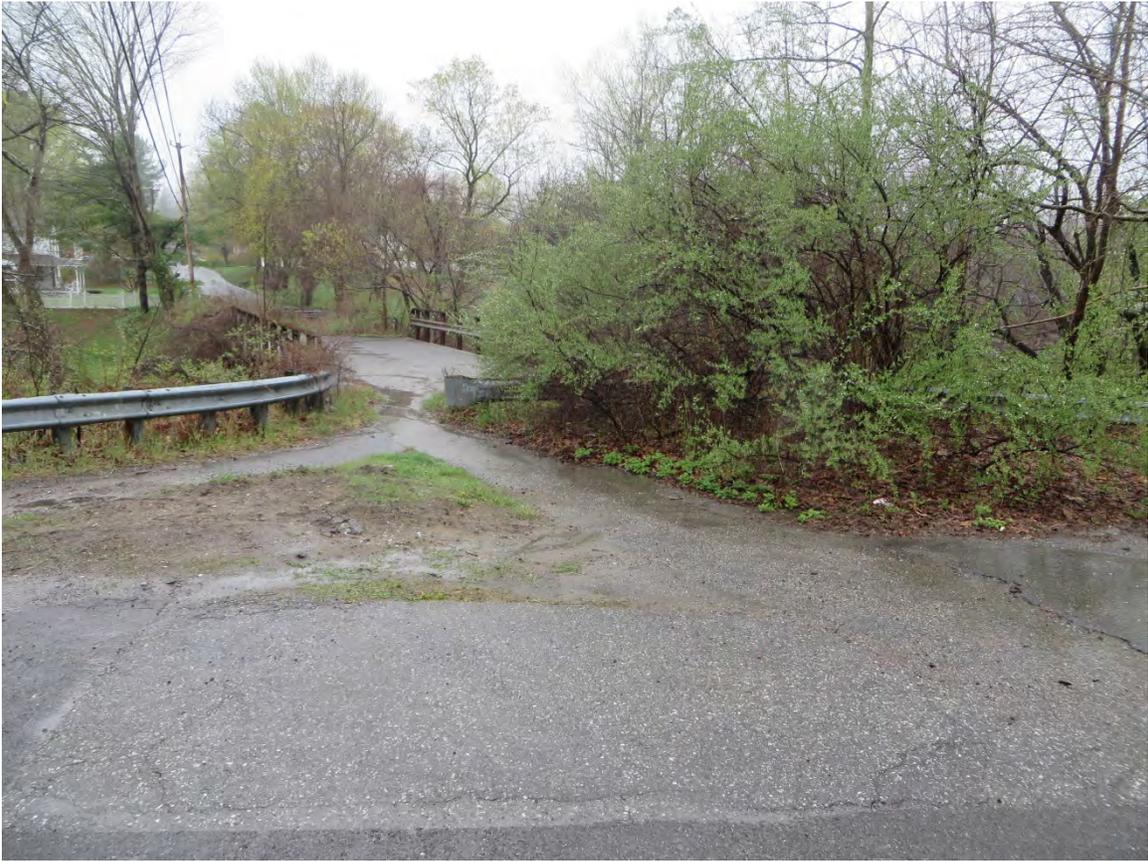
Photograph S21: Facing southwest to the Lanesville Road Bridge over the Still River at the south end of Frank's Lane and Harrybrooke Park's northern parking lot.

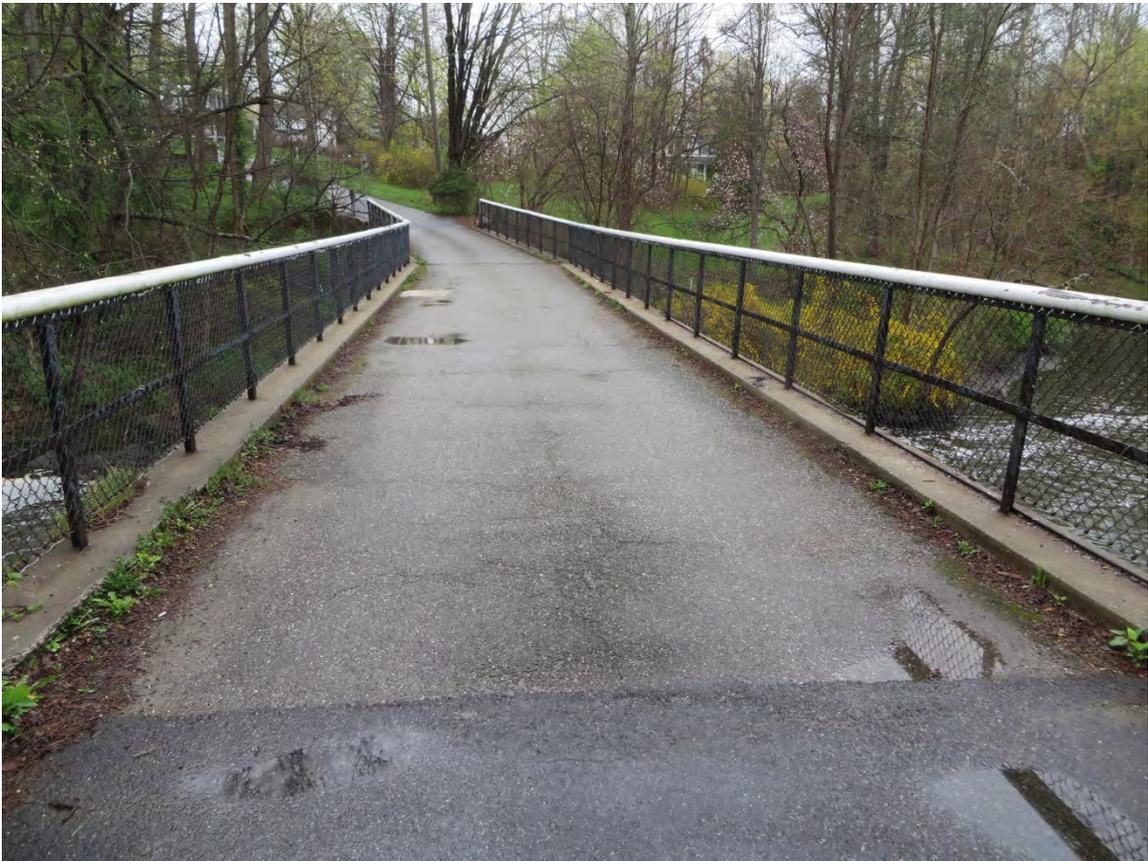
Photograph S22: Facing northwest to the existing Harrybrooke Park Bridge over the Still River that exits onto Lanesville Road.

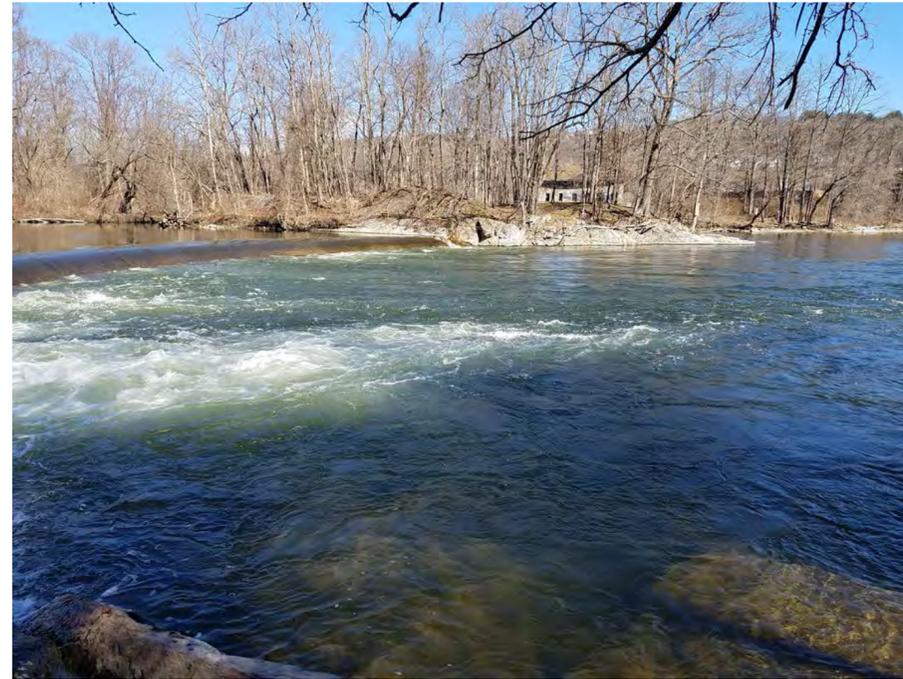
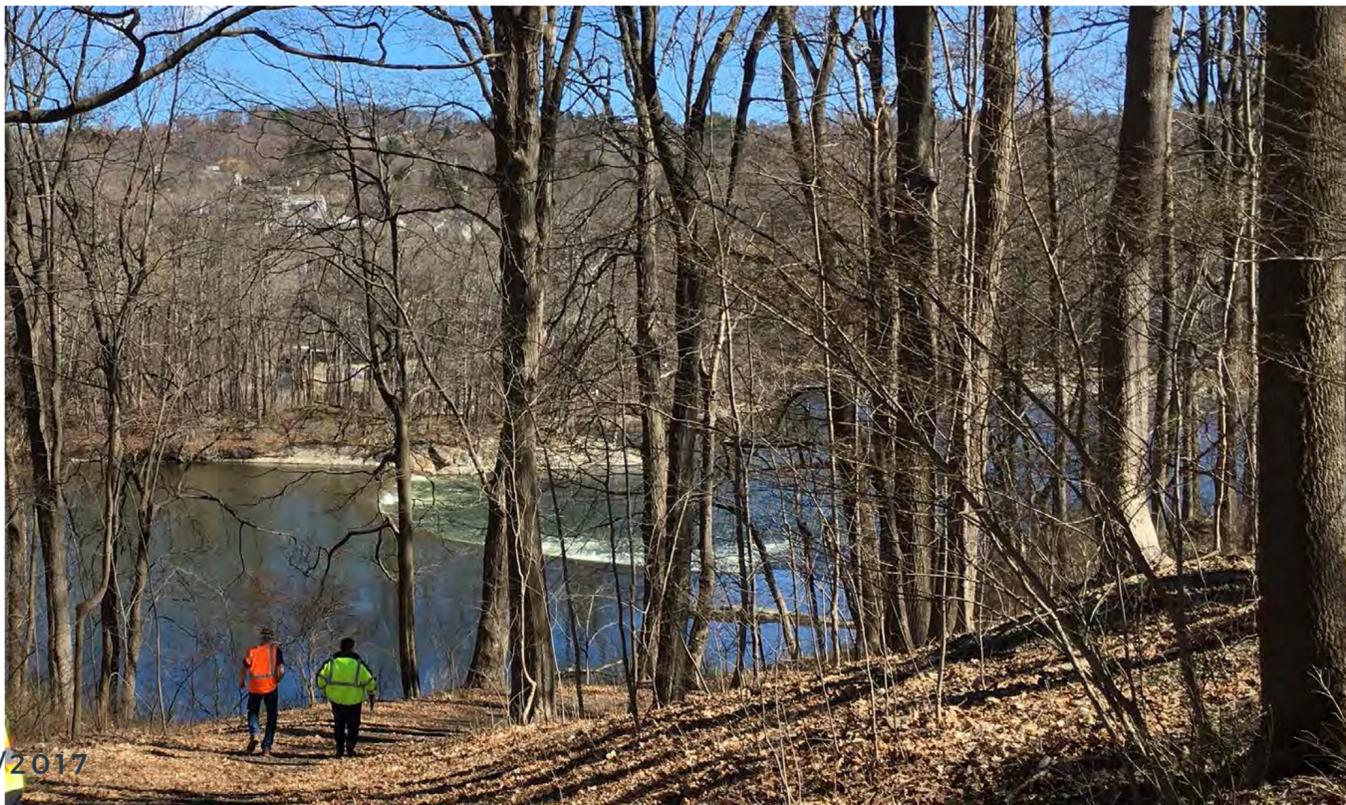
PHASE 3: HIDDEN TREASURE BRIDGE & TRAIL

- 2 Bridge Sections, 175 & 285 Feet In Length
- Boardwalk To Bridge Elevation
- Trail On West Side Connecting to Pickett District Road
- Maintain Foot Path And Fishing Access

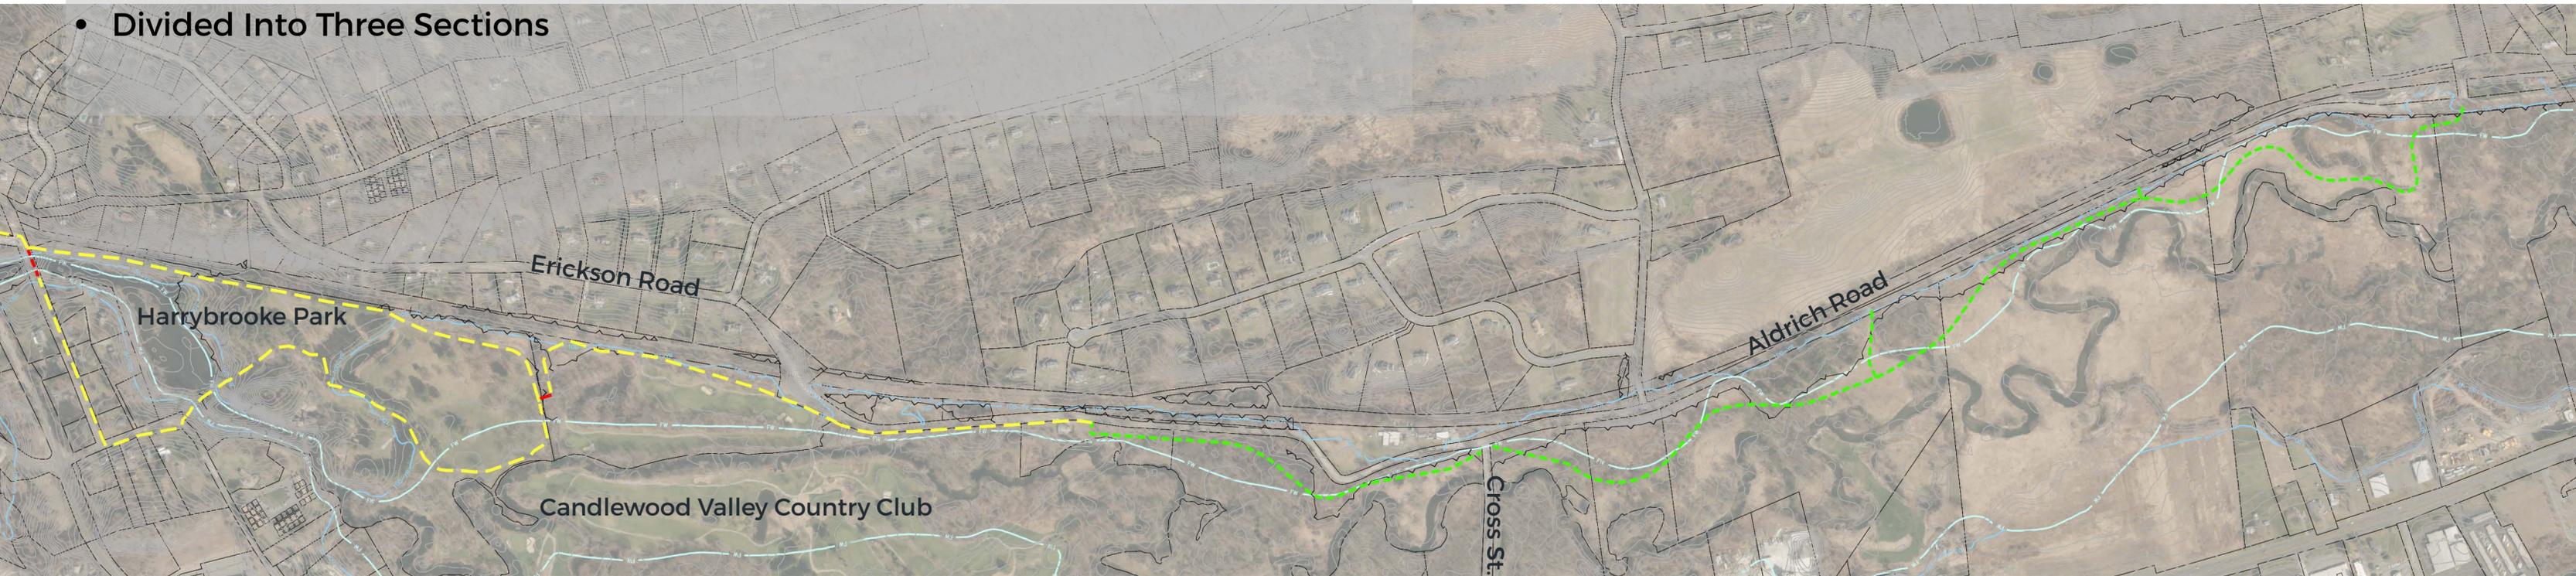
PHASE 5: HARRYBROOKE PARK TO BROOKFIELD

- Approximately 3.5 Miles In Length including Loop Through Harrybrooke Park
- Facility Types: Shared Use Path, Sidepath, Soft Trail
- Divided Into Three Sections
